# PIERCE ELEMENTARY SCHOOL

Outlet Sampling and Plumbing Assessment Recommendations

1101 West Vernon Drive, Flint, Michigan 48503

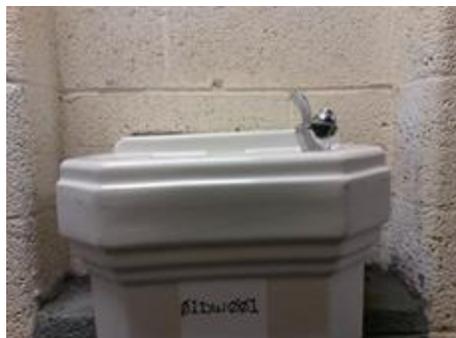
### **Outlet:     Bubbler Drinking Fountain (01DW001)**

Location:   Hallway next to Boiler Room, behind Stage

Results:     P1=20 parts per billion, P2=2 parts per billion  
              F01=2 parts per billion, F02=non-detect

These results suggest the highest contribution of lead may be from the bubbler itself. This bubbler fixture is made of chrome-plated brass. Connecting plumbing should be checked for brass components, including brass valves.

Replacement of this bubbler tap and its connecting plumbing with lead-free materials will significantly reduce lead exposure at this location. If replacement is not currently feasible, sample results indicate that flushing this tap for three minutes following periods of stagnation is likely to reduce lead concentrations and lead exposure.

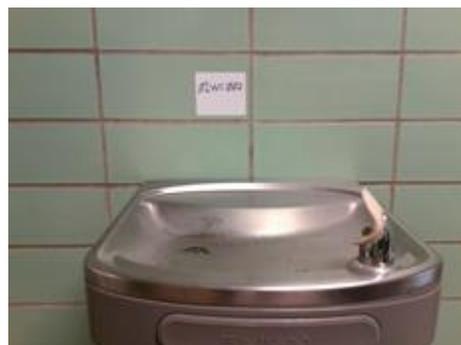
### **Outlet:     Water Cooler Fountain (01WC002)**

Location:   Hallway next to Mechanical Room, north corridor

Results:     P1=8 parts per billion, P2=13 parts per billion  
              F01=35 parts per billion, F02=19 parts per billion

These results suggest the lead may be from the water cooler unit and the connecting plumbing. The water cooler is an Elkay model. This model may contain brass components. Connecting plumbing to the cooler unit may also contain brass components.

Replacement of this water cooler and its connecting plumbing with lead-free materials will significantly reduce lead exposure at this location and needs to be completed for use. If replacement is not currently feasible, **SHUT OFF THIS WATER COOLER FOUNTAIN AND DO NOT USE THIS WATER COOLER FOR DRINKING OR COOKING.**

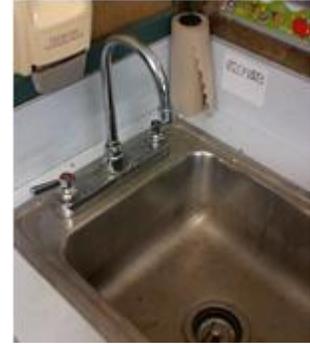
**Outlet: Sink Faucet (01CF003)**

Location: Classroom 109, northeast wall

Results: P1=26 parts per billion, P2=17 parts per billion  
F01=9 part per billion, F02=2 parts per billion

These results suggest the highest contribution of lead may be from the faucet and its connecting plumbing. This model faucet typically has a brass tube in its deck body, and may contain some additional brass components. Connecting plumbing in the cabinet under the sink should be checked for brass components, including brass valves.

Replacement of this faucet and its connecting plumbing with lead-free materials will significantly reduce lead exposure at this location. If replacement is not currently feasible, sample results indicate that flushing this tap for three minutes following periods of stagnation is likely to reduce lead concentrations and lead exposure.

This faucet also has an aerator/screen at the outlet. If the faucet is not replaced, the aerator/screen should be removed, inspected for particulate accumulations, scrubbed clean, and reinstalled. If particulates are found, the aerator/screen should be periodically checked and cleaned.

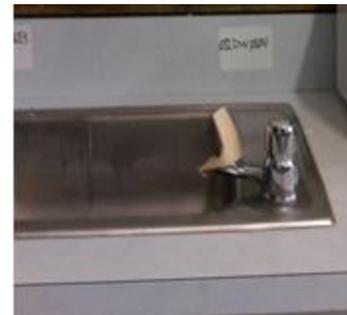
**Outlet: Bubbler Fountain (01DW004)**

Location: Classroom 109, northwest wall

Results: P1=42 parts per billion, P2=17 parts per billion  
F01=3 parts per billion, F02=1 part per billion

These results suggest the highest contribution of lead may be from the bubbler and its connecting plumbing. This bubbler fixture is made of chrome-plated brass and has a brass connector on the underside of the sink. Connecting plumbing in the cabinet under the sink should be checked for brass connectors, copper piping with lead solder, and a brass shut-off valve.

Replacement of this bubbler tap and its connecting plumbing with lead-free materials will significantly reduce lead exposure at this location. If replacement is not currently feasible, sample results indicate that flushing this tap for three minutes following periods of stagnation is likely to reduce lead concentrations and lead exposure.

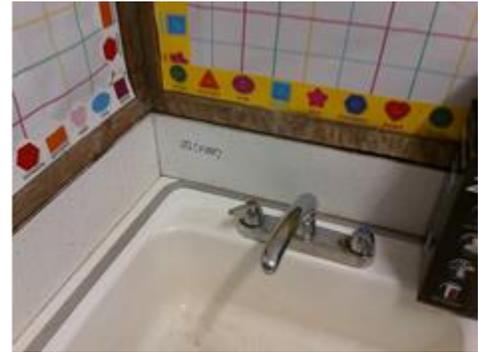
### **Outlet: Sink Faucet (01CF007)**

Location: Classroom 108, northwest wall

Results: P1=97 parts per billion, P2=132 parts per billion  
F01=9 parts per billion, F02=2 parts per billion

These results suggest the highest contribution of lead may be from the faucet and its connecting plumbing. This faucet appears to be manufactured by Central Brass. This model faucet typically has a brass tube in its deck body, may contain some additional brass components, and has a brass spout. Connecting plumbing in the cabinet under the sink should be checked for brass connectors, copper piping with lead solder, and brass shut-off valves.

Replacement of this faucet and its connecting plumbing with lead-free materials will significantly reduce lead exposure at this location. If replacement is not currently feasible, sample results indicate that flushing this tap for three minutes following periods of stagnation is likely to reduce lead concentrations and lead exposure.

This faucet also has an aerator/screen at the outlet. If the faucet is not replaced, the aerator/screen should be removed, inspected for particulate accumulations, scrubbed clean, and reinstalled. If particulates are found, the aerator/screen should be periodically checked and cleaned.

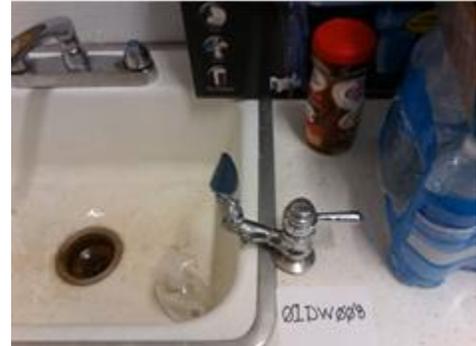
### **Outlet: Bubbler Fountain (01DW008)**

Location: Classroom 108, northwest wall

Results: P1=468 parts per billion, P2=75 parts per billion  
F01=6 parts per billion, F02=4 parts per billion

These results suggest the highest contribution of lead may be from the bubbler and its connecting plumbing. This bubbler fixture is made of chrome-plated brass, with a brass operating valve, and a brass connector on the underside of the sink. Connecting plumbing under the sink should be checked for brass components and copper piping with lead solder.

Replacement of this bubbler tap and its connecting plumbing with lead-free materials will significantly reduce lead exposure at this location. If replacement is not currently feasible, sample results indicate that flushing this tap for three minutes following periods of stagnation is likely to reduce lead concentrations and lead exposure.

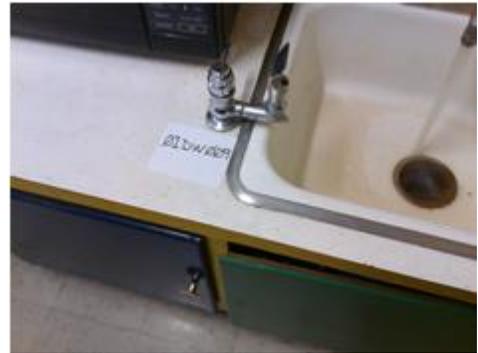
### **Outlet: Bubblers Fountain (01DW009)**

Location: Classroom 111, northeast wall

Results: P1=26 parts per billion, P2=38 parts per billion  
F01=7 parts per billion, F02=3 parts per billion

These results suggest the highest contribution of lead may be from the bubbler and its connecting plumbing. This bubbler fixture is made of chrome-plated brass, with a brass operating valve, and a brass connector on the underside of the sink. Connecting plumbing in the cabinet under the sink should be checked for brass components and copper piping with lead solder.

Replacement of this bubbler tap and its connecting plumbing with lead-free materials will significantly reduce lead exposure at this location. If replacement is not currently feasible, sample results indicate that flushing this tap for three minutes following periods of stagnation is likely to reduce lead concentrations and lead exposure.

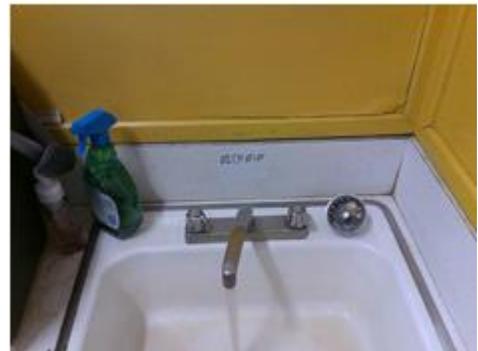
### **Outlet: Sink Faucet (01CF010)**

Location: Classroom 111, northeast wall

Results: P1=43 parts per billion, P2=22 parts per billion  
F01=3 parts per billion, F02=3 parts per billion

These results suggest the highest contribution of lead may be from the faucet and its connecting plumbing. This faucet appears to be manufactured by Central Brass. This model faucet typically has a brass tube in its deck body, may contain some additional brass components, and has a brass spout. The spout's chrome finish is worn down to the brass. Connecting plumbing in the cabinet under the sink should be checked for brass connectors, copper piping with lead solder, and brass shut-off valves.

Replacement of this faucet and its connecting plumbing with lead-free materials will significantly reduce lead exposure at this location. If replacement is not currently feasible, sample results indicate that flushing this tap for three minutes following periods of stagnation is likely to reduce lead concentrations and lead exposure.

This faucet also has an aerator/screen at the outlet. If the faucet is not replaced, the aerator/screen should be removed, inspected for particulate accumulations, scrubbed clean, and reinstalled. If particulates are found, the aerator/screen should be periodically checked and cleaned.

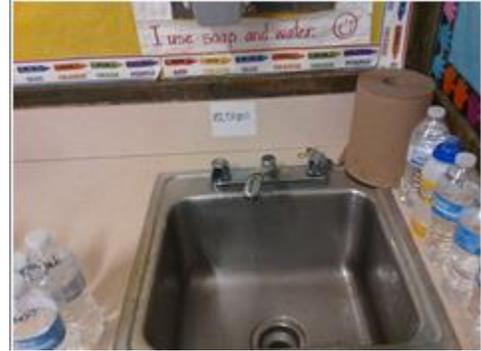
### **Outlet: Sink Faucet (01CF011)**

Location: Classroom 107, southwest wall

Results: P1=25 parts per billion, P2=11 parts per billion  
F01=3 parts per billion, F02=2 parts per billion

These results suggest the highest contribution of lead may be from the faucet and its connecting plumbing. This faucet appears to be manufactured by Central Brass. This model faucet typically has a brass tube in its deck body, may contain some additional brass components, and has a brass spout. Connecting plumbing in the cabinet under the sink should be checked for brass connectors, copper piping with lead solder, and brass shut-off valves.

Replacement of this sink faucet and its connecting plumbing with lead-free materials will significantly reduce lead exposure at this location. If replacement is not currently feasible, sample results indicate that flushing this tap for three minutes following periods of stagnation is likely to reduce lead concentrations and lead exposure.

At the time of assessment, the faucet aerator/screen was found removed. If the faucet is not replaced and the aerator/screen is going to be reinstalled, it should be inspected for particulate accumulations, and scrubbed clean. If particulates are found, the aerator/screen should be periodically checked and cleaned.

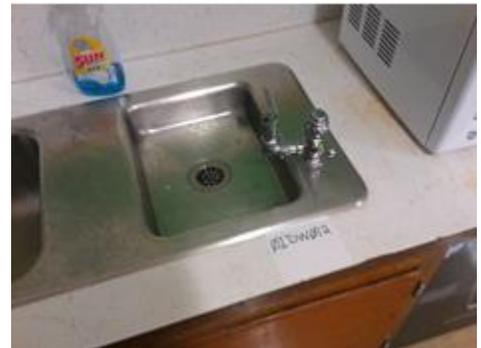
### **Outlet: Bubbler Fountain (01DW012)**

Location: Classroom 112, southwest wall

Results: P1=78 parts per billion, P2=11 parts per billion  
F01=4 parts per billion, F02=3 parts per billion

These results suggest the highest contribution of lead may be from the bubbler and its connecting plumbing. This bubbler fixture is made of chrome-plated brass, with a brass operating valve and a brass connector on the underside of the sink. Connecting plumbing under the sink should be checked for brass components and copper piping with lead solder.

Replacement of this bubbler tap and its connecting plumbing with lead-free materials will significantly reduce lead exposure at this location. If replacement is not currently feasible, sample results indicate that flushing this tap for three minutes following periods of stagnation is likely to reduce lead concentrations and lead exposure.

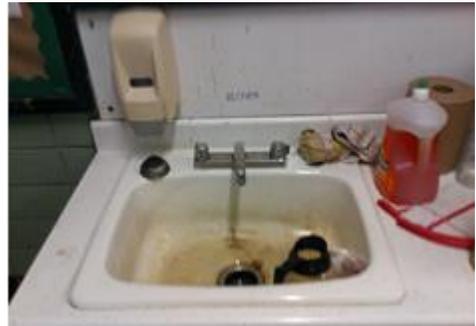
### **Outlet: Sink Faucet (01CF018)**

Location: Classroom 301, northwest wall  
Results: P1=13 parts per billion, P2=16 parts per billion  
F01=4 parts per billion, F02=1 part per billion

These results suggest the highest contribution of lead may be from the faucet and its connecting plumbing. This faucet appears to be manufactured by Central Brass. This model faucet typically has a brass tube in its deck body, may contain some additional brass components, and has a brass spout. The spout's chrome finish is worn down to the brass. Connecting plumbing in the cabinet under the sink should be checked for brass connectors, copper piping with lead solder, and brass shut-off valves.

Replacement of this faucet and its connecting plumbing with lead-free materials will significantly reduce lead exposure at this location. If replacement is not currently feasible, sample results indicate that flushing this tap for three minutes following periods of stagnation is likely to reduce lead concentrations and lead exposure.

This faucet also appears to have an aerator/screen at the outlet. If the faucet is not replaced, the aerator/screen should be removed, inspected for particulate accumulations, scrubbed clean, and reinstalled. If particulates are found, the aerator/screen should be periodically checked and cleaned.

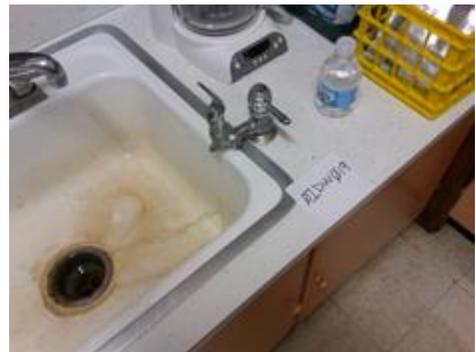
### **Outlet: Bubbler Fountain (01DW019)**

Location: Classroom 302, southwest wall  
Results: P1=220 parts per billion, P2=23 parts per billion  
F01=3 parts per billion, F02=2 parts per billion

These results suggest the highest contribution of lead may be from the bubbler and its connecting plumbing. This bubbler fixture is made of chrome-plated brass, with a brass operating valve, and a brass connector on the underside of the sink. Connecting plumbing in the cabinet under the sink should be checked for brass components and copper piping with lead solder.

Replacement of this bubbler tap and its connecting plumbing with lead-free materials will significantly reduce lead exposure at this location. If replacement is not currently feasible, sample results indicate that flushing this tap for three minutes following periods of stagnation is likely to reduce lead concentrations and lead exposure.

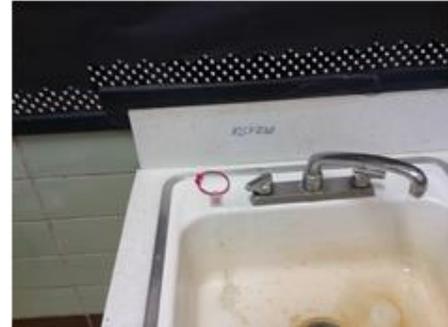
**Outlet: Sink Faucet (01CF020)**

Location: Classroom 302, southwest wall  
Results: P1=53 parts per billion, P2=30 parts per billion  
F01=1 part per billion, F02=non-detect

These results suggest the highest contribution of lead may be from the faucet and its connecting plumbing. This faucet appears to be manufactured by Central Brass. The base of this faucet is chrome-plated brass, has brass components within the base, and a brass spout. The spout's chrome finish is worn down to the brass. Connecting plumbing in the cabinet under the sink should be checked for brass connectors, copper piping with lead solder, and brass shut-off valves.

Replacement of this faucet and its connecting plumbing with lead-free materials will significantly reduce lead exposure at this location. If replacement is not currently feasible, sample results indicate that flushing this tap for three minutes following periods of stagnation is likely to reduce lead concentrations and lead exposure.

This faucet also appears to have an aerator/screen at the outlet. If the faucet is not replaced, the aerator/screen should be removed, inspected for particulate accumulations, scrubbed clean, and reinstalled. If particulates are found, the aerator/screen should be periodically checked and cleaned.

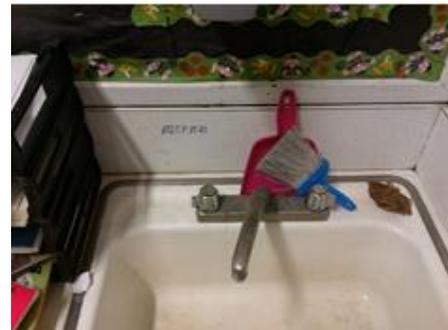
**Outlet: Sink Faucet (01CF021)**

Location: Classroom 306, southwest wall  
Results: P1=15 parts per billion, P2=50 parts per billion  
F01=8 parts per billion, F02=3 parts per billion

These results suggest the highest contribution of lead may be from the faucet and its connecting plumbing. This faucet appears to be manufactured by Central Brass. This model faucet typically has a brass tube in its deck body, may contain some additional brass components, and has a brass spout. The spout's chrome finish is worn down to the brass. Connecting plumbing in the cabinet under the sink should be checked for brass connectors, copper piping with lead solder, and brass shut-off valves.

Replacement of this faucet and its connecting plumbing with lead-free materials will significantly reduce lead exposure at this location. If replacement is not currently feasible, sample results indicate that flushing this tap for three minutes following periods of stagnation is likely to reduce lead concentrations and lead exposure.

This faucet also appears to have an aerator/screen at the outlet. If the faucet is not replaced, the aerator/screen should be removed, inspected for particulate accumulations, scrubbed clean, and reinstalled. If particulates are found, the aerator/screen should be periodically checked and cleaned.

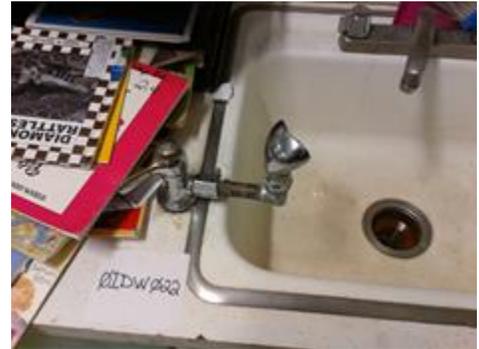
### Outlet: Bubblers Fountain (01DW022)

Location: Classroom 306, southwest wall

Results: P1=17 parts per billion, P2=6 parts per billion  
F01=4 parts per billion, F02=13 parts per billion

These results suggest lead may be from the bubbler and its connecting plumbing. This bubbler fixture is made of chrome-plated brass, with a brass operating valve, and a brass connector on the underside of the sink. Connecting plumbing in the cabinet under the sink should be checked for brass components and copper piping with lead solder. The increase in the fourth sample (F02) results may be a result of excessive water stagnation in this area of the building.

Replacement of this bubbler and its connecting plumbing with lead-free materials will significantly reduce lead exposure at this location, along with an overall flushing program. If replacement is not currently feasible, sample results indicate that flushing this tap for three minutes following periods of stagnation is likely to reduce lead concentrations and lead exposure.

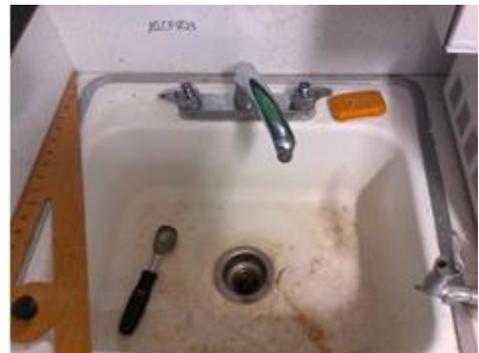
### Outlet: Sink Faucet (01CF023)

Location: Classroom 312, southeast wall

Results: P1=22 parts per billion, P2=14 parts per billion  
F01=9 parts per billion, F02=6 parts per billion

These results suggest the highest contribution of lead may be from the faucet and its connecting plumbing. This faucet appears to be manufactured by Chicago Specialty. This model faucet typically has a brass tube in its deck body, may contain some additional brass components, and has a brass spout. The spout's chrome finish is worn down to the brass. Connecting plumbing in the cabinet under the sink should be checked for brass connectors, copper piping with lead solder, and brass shut-off valves.

Replacement of this faucet and its connecting plumbing with lead-free materials will significantly reduce lead exposure at this location. If replacement is not currently feasible, sample results indicate that flushing this tap for three minutes following periods of stagnation is likely to reduce lead concentrations and lead exposure.

This faucet also appears to have an aerator/screen at the outlet. If the faucet is not replaced, the aerator/screen should be removed, inspected for particulate accumulations, scrubbed clean, and reinstalled. If particulates are found, the aerator/screen should be periodically checked and cleaned.

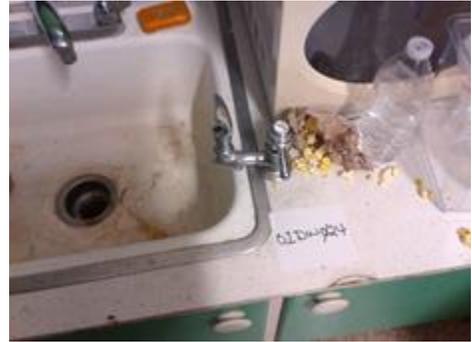
**Outlet: Bubblers Fountain (01DW024)**

Location: Classroom 312, southeast wall  
Results: P1=36 parts per billion, P2=8 parts per billion  
F01=6 parts per billion, F02=4 parts per billion

These results suggest the highest contribution of lead may be from the bubbler and its connecting plumbing. This bubbler fixture is made of chrome-plated brass, with a brass operating valve, and a brass connector on the underside of the sink. Connecting plumbing in the cabinet under the sink should be checked for brass components and copper piping with lead solder.

Replacement of this bubbler tap and its connecting plumbing with lead-free materials will significantly reduce lead exposure at this location. If replacement is not currently feasible, sample results indicate that flushing this tap for three minutes following periods of stagnation is likely to reduce lead concentrations and lead exposure.

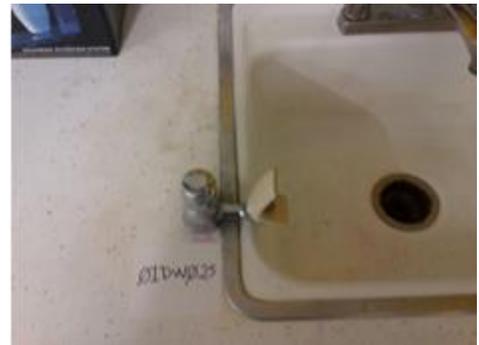
**Outlet: Bubblers Fountain (01DW025)**

These results suggest the highest contribution of lead may be from the bubbler and its connecting plumbing. This bubbler fixture is made of chrome-plated brass and has a brass connector on the underside of the sink. Connecting plumbing in the cabinet under the sink should be checked for brass connectors, copper piping with lead solder, and a brass shut-off valve.

Copper results for sample P1 at this location were also at levels above which the DEQ recommends school facilities take action. Copper results suggest these same brass components are contributing to this condition.

Replacement of this bubbler tap and its connecting plumbing with lead-free materials will significantly reduce lead and copper exposure at this location. If replacement is not currently feasible, sample results indicate that flushing this tap for three minutes following periods of stagnation is likely to reduce lead and copper concentrations and lead and copper exposure.

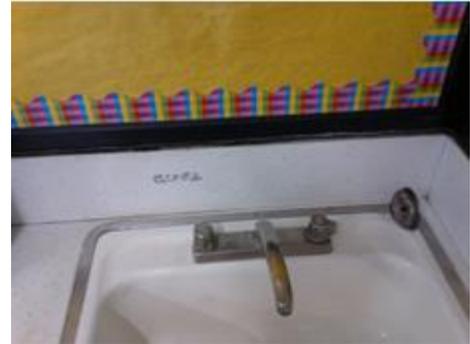
### Outlet: Sink Faucet (01CF026)

These results suggest the highest contribution of lead may be from the faucet and its connecting plumbing. This faucet appears to be manufactured by Central Brass. This model faucet typically has a brass tube in its deck body and, may contain some additional brass components, and has a brass spout. The spout's chrome finish is worn down to the brass. Connecting plumbing in the cabinet under the sink should be checked for brass connectors, copper piping with lead solder, and brass shut-off valves.

Replacement of this faucet and its connecting plumbing with lead-free materials will significantly reduce lead exposure at this location. If replacement is not currently feasible, sample results indicate that flushing this tap for three minutes following periods of stagnation is likely to reduce lead concentrations and lead exposure.

This faucet also appears to have an aerator/screen at the outlet. If the faucet is not replaced, the aerator/screen should be removed, inspected for particulate accumulations, scrubbed clean, and reinstalled. If particulates are found, the aerator/screen should be periodically checked and cleaned.

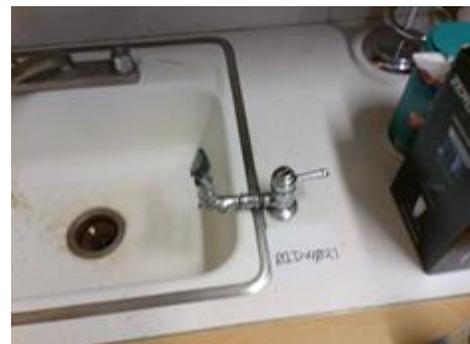
### Outlet: Bubbler Fountain (01DW027)

These results suggest lead may be from the bubbler and its connecting plumbing. This bubbler fixture is made of chrome-plated brass, with a brass operating valve, and a brass connector on the underside of the sink. Connecting plumbing in the cabinet under the sink should be checked for brass components and copper piping with lead solder. The increase in the third (F01) and fourth sample (F02) results may be a result of excessive water stagnation in this area of the building.

Replacement of this bubbler tap and its connecting plumbing with lead-free materials will significantly reduce lead exposure at this location and needs to be completed. In addition, an overall flushing program is required – even after this bubbler is replaced. If replacement is not currently feasible, **SHUT OFF THIS BUBBLER AND DO NOT USE THIS BUBBLER FOR DRINKING OR COOKING.**

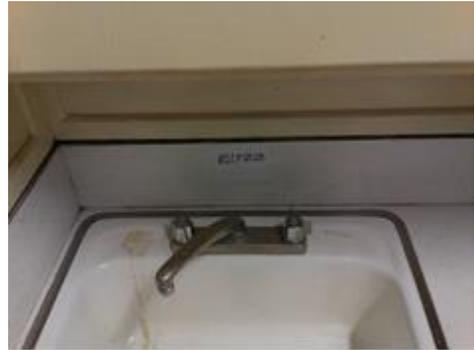
These results suggest the highest contribution of lead may be from the faucet and its connecting plumbing. This faucet appears to be manufactured by Central Brass. This model faucet typically has a brass tube in its deck body, may contain some additional brass components, and has a brass spout. The spout's chrome finish is worn down to the brass. Connecting plumbing in the cabinet under the sink should be checked for brass connectors, copper piping with lead solder, and brass shut-off valves.

Replacement of this faucet and its connecting plumbing with lead-free materials will significantly reduce lead exposure at this location and needs to be completed. In addition, an overall flushing program is required – even after this faucet is replaced. If a replacement is not currently feasible, **DO NOT USE THIS FAUCET FOR DRINKING OR COOKING.**

This faucet also appears to have an aerator/screen at the outlet. If the faucet is not replaced, the aerator/screen should be removed, inspected for particulate accumulations, scrubbed clean, and reinstalled. If particulates are found, the aerator/screen should be periodically checked and cleaned.

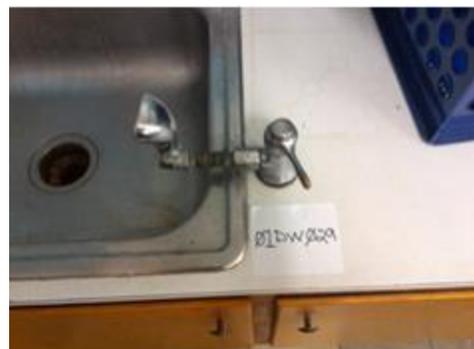
These results suggest the highest contribution of lead may be from the bubbler and its connecting plumbing. This bubbler fixture is made of chrome-plated brass, with a brass operating valve, and a brass connector on the underside of the sink. The bubbler also has been modified with added copper couplings below the spout. Connecting plumbing in the cabinet under the sink should be checked for brass components and copper piping with lead solder.

Replacement of this bubbler tap and its connecting plumbing with lead-free materials will significantly reduce lead exposure at this location. If replacement is not currently feasible, sample results indicate that flushing this tap for three minutes.

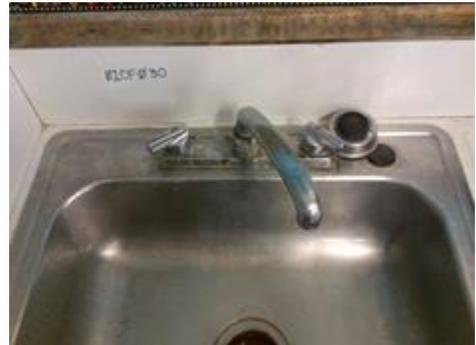
These results suggest the highest contribution of lead may be from the faucet and its connecting plumbing. This faucet appears to be manufactured by Central Brass. This model faucet typically has a brass tube in its deck body, may contain some additional brass components, and has a brass spout. The spout's chrome finish is worn down to the brass. Connecting plumbing in the cabinet under the sink should be checked for brass connectors, copper piping with lead solder, and brass shut-off valves.

Replacement of this faucet and its connecting plumbing with lead-free materials will significantly reduce lead exposure at this location. If replacement is not currently feasible, sample results indicate that flushing this tap for three minutes following periods of stagnation is likely to reduce lead concentrations and lead exposure.

This faucet also appears to have an aerator/screen at the outlet. If the faucet is not replaced, the aerator/screen should be removed, inspected for particulate accumulations, scrubbed clean, and reinstalled. If particulates are found, the aerator/screen should be periodically checked and cleaned.

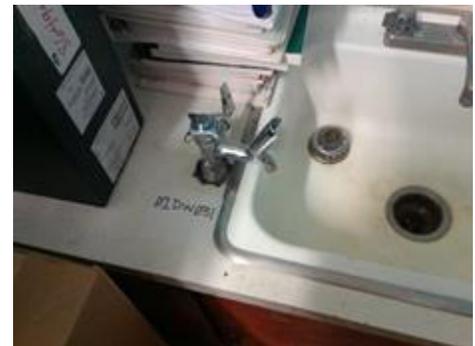
These results suggest the highest contribution of lead may be from the bubbler and its connecting plumbing. This bubbler fixture is made of chrome-plated brass and has a brass connector on the underside of the sink. Connecting plumbing in the cabinet under the sink should be checked for brass components and copper piping with lead solder.

Replacement of this bubbler tap and its connecting plumbing with lead-free materials will significantly reduce lead exposure at this location. If replacement is not currently feasible, sample results indicate that flushing this tap for three minutes following periods of stagnation is likely to reduce lead concentrations and lead exposure.

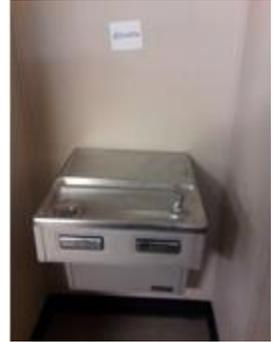
Copper results for sample P1 at this location were also at levels above which the DEQ recommends school facilities take action. Copper results suggest these same brass components are contributing to this condition.

Replacement of the entire unit is recommended and will significantly reduce lead and copper exposure at this location. If replacement is not currently feasible, sample results indicate that flushing this tap for three minutes following periods of stagnation is likely to reduce lead and copper concentrations and lead and copper exposure.
