## SUMMARY - KALAMAZOO RIVER BANK EROSION MONITORING TRIP NO.1

**ENBRIDGE LINE 6B INCIDENT  
KALAMAZOO RIVER BANK EROSION ASSESSMENT AND  
ACTION PLAN**

Photo Log  
Monitoring Trip No.1  
11/18/10 to 11/20/10

# ENBRIDGE LINE 6B INCIDENT KALAMAZOO RIVER BANK STABILIZATION DESIGN PRIORITY AREAS ADDENDUM NO.1

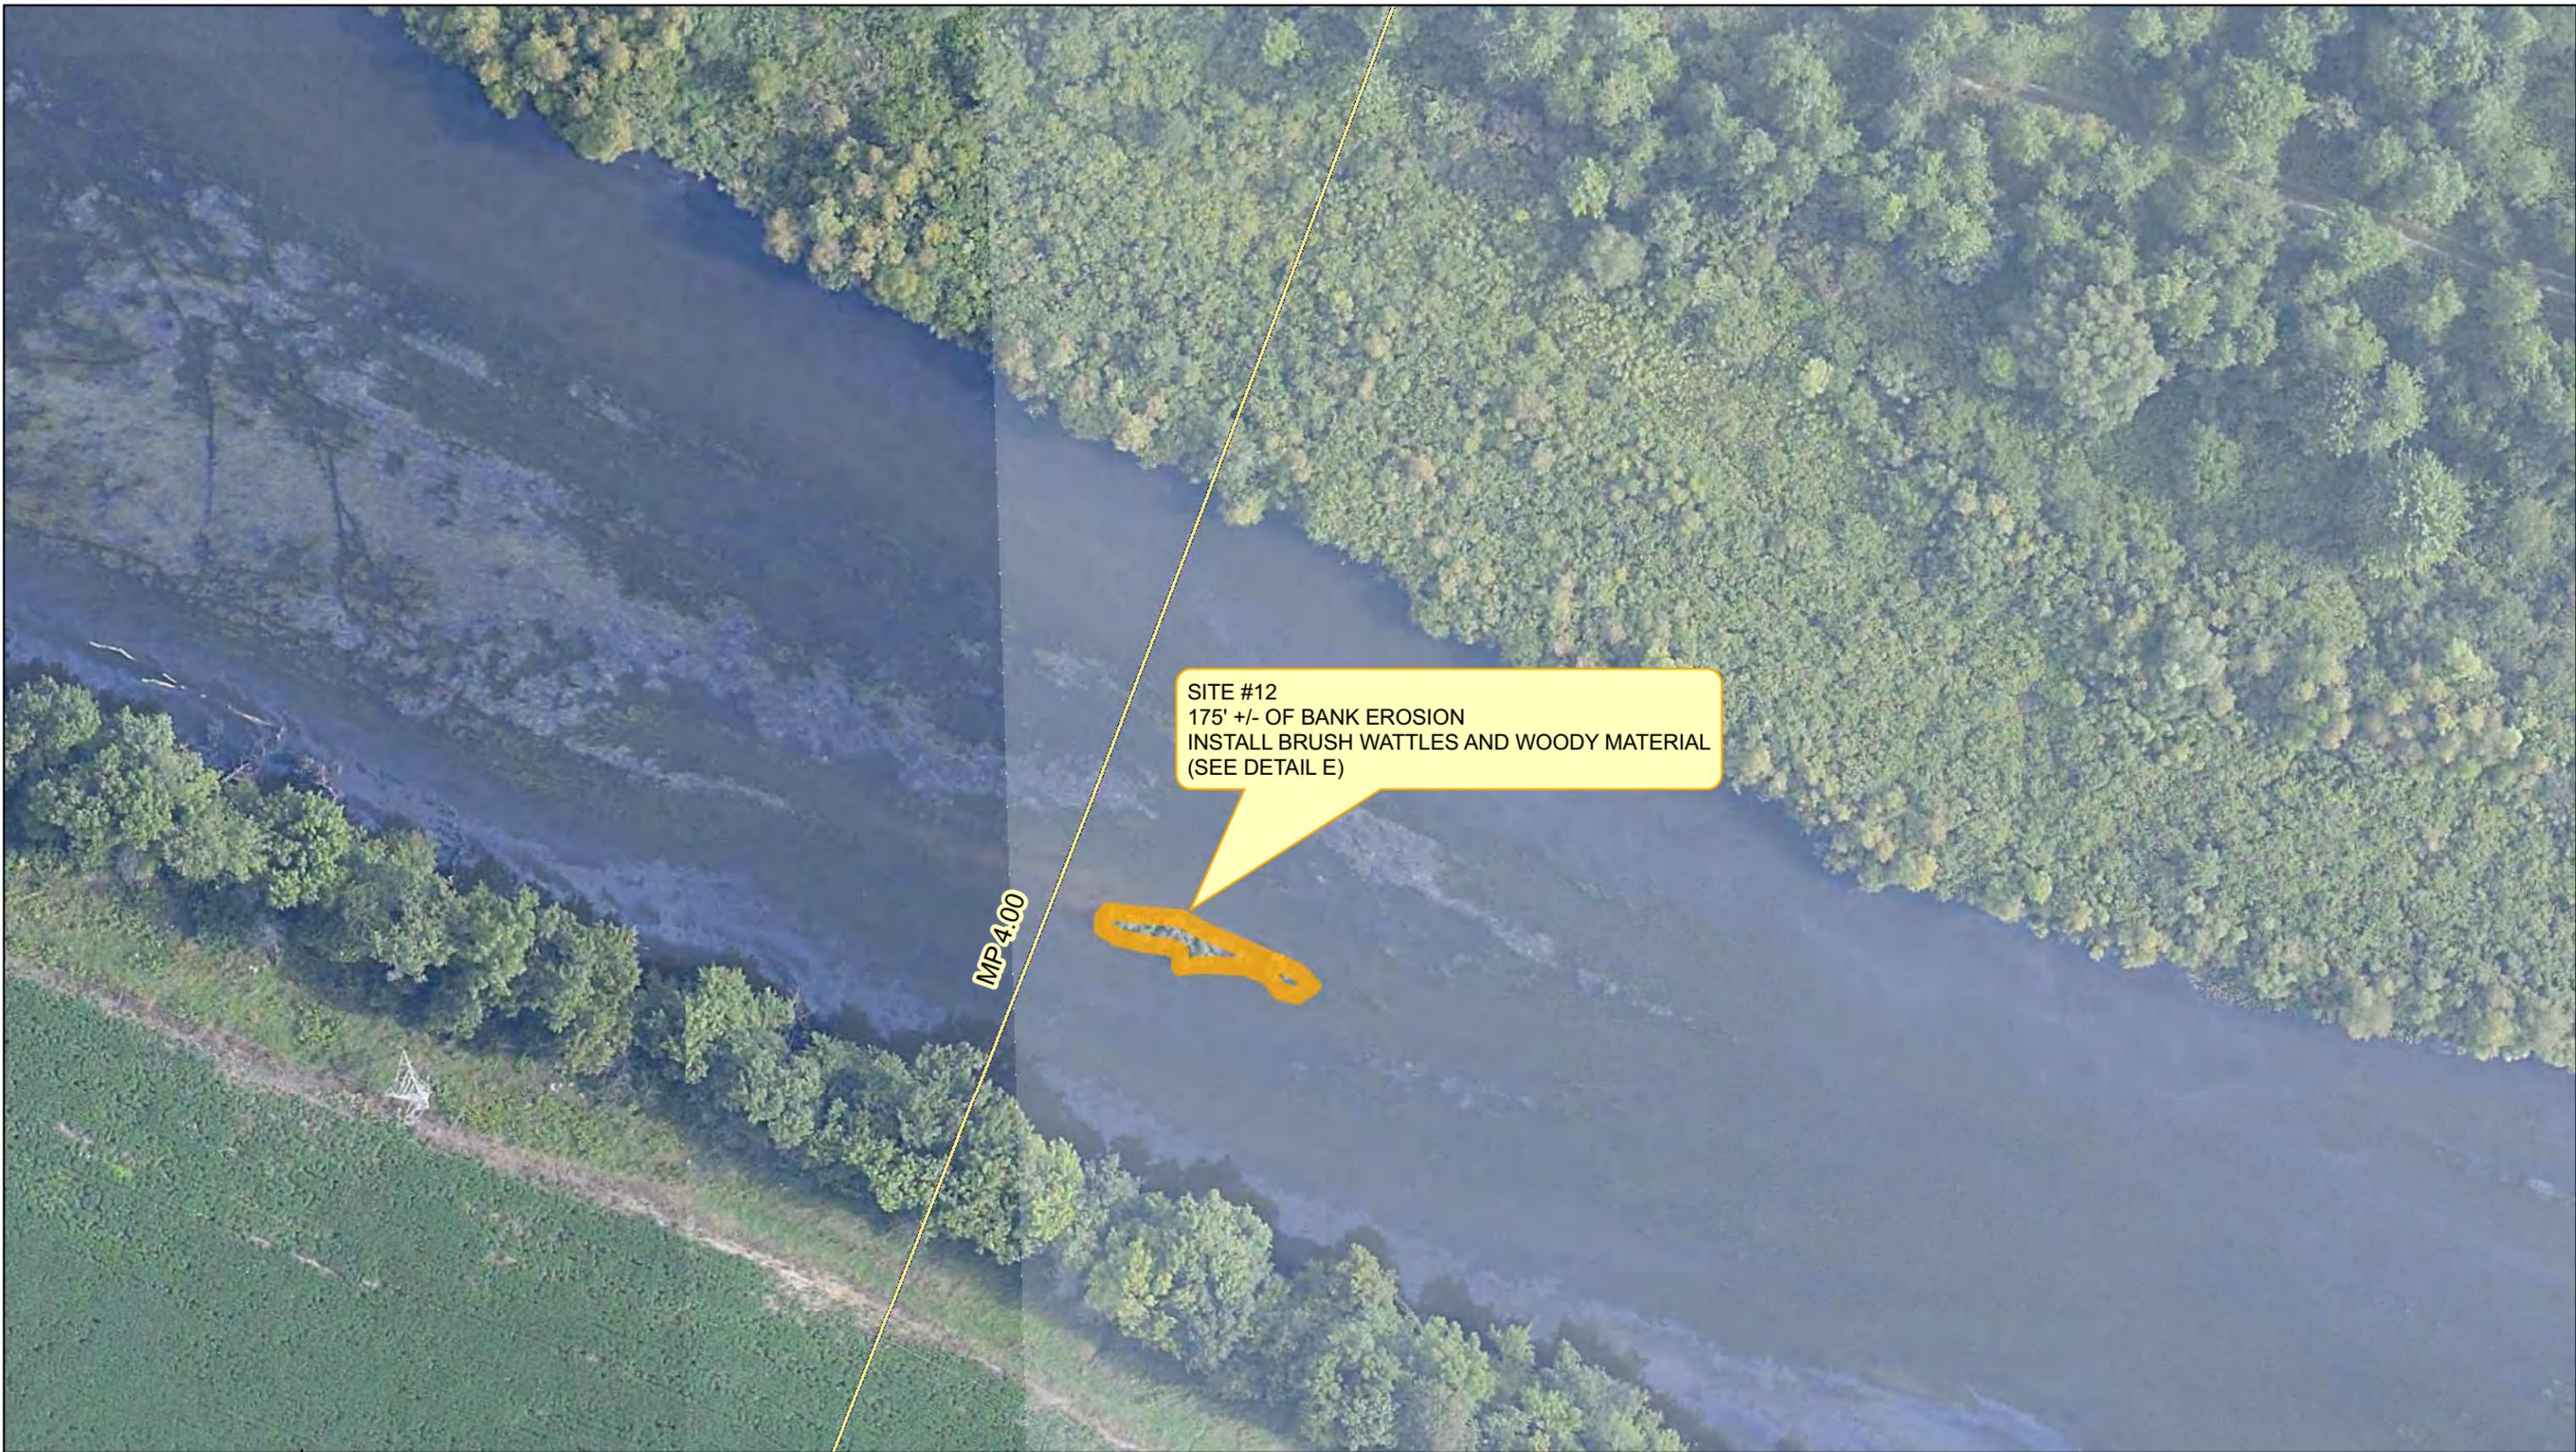
FIGURE 1  
SITE #12  
BANK EROSION STABILIZATION DESIGN  
ADDENDUM NO.1

SITE #12  
175' +/- OF BANK EROSION  
INSTALL BRUSH WATTLES AND WOODY MATERIAL  
(SEE DETAIL E)
