ROAD REPOSITIONING ISSUES

January 31, 2001

The following pages are examples of Road repositioning issues encountered in the Michigan Geographic Framework. They are presented here in draft form for consideration by Framework users and partners. Please review these examples and feel free to provide feedback to:

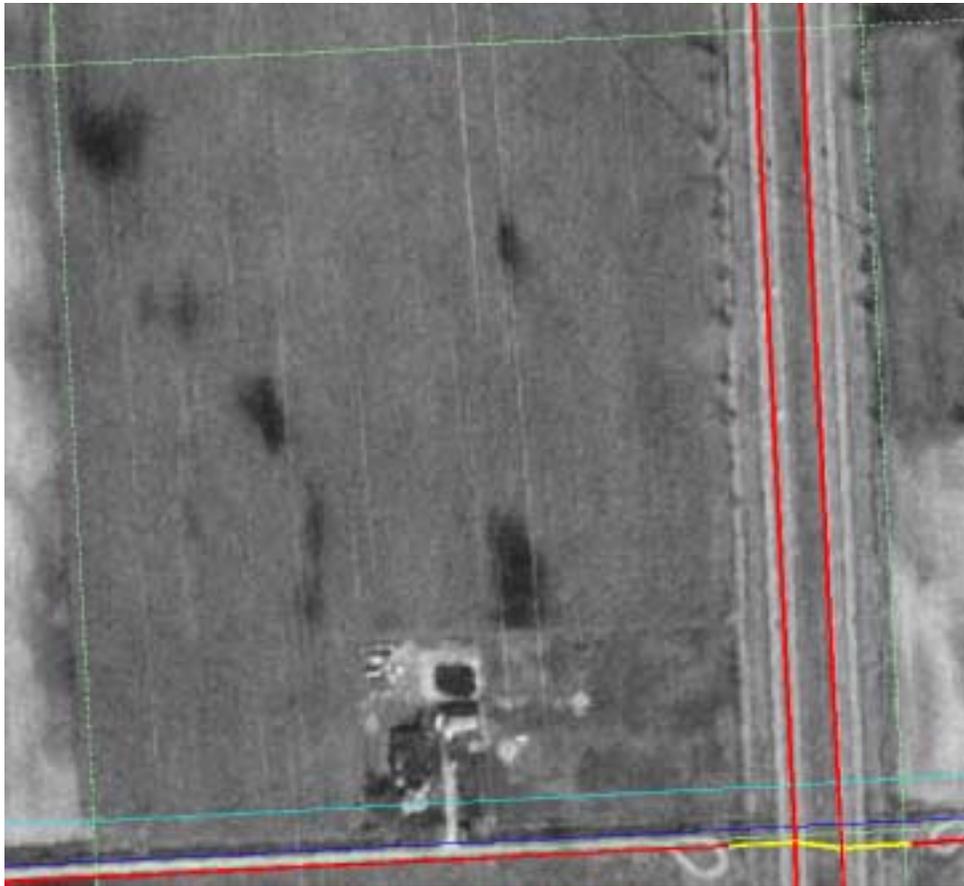
A thick yellow line represents an arc that was classified as a road in MIRIS, but not a road in TIGER. During Phase2, it was discovered that the road does not cross the highway. Therefore, a PR was not posted on the road. This arc has been flagged yellow indicating the need for investigation during repositioning. While investigating the arc, the Repositioner determined that the yellow arcs are not road features. However, these arcs represent a Minor Civil Division (MCD) boundary. Therefore, the arcs could not be deleted.

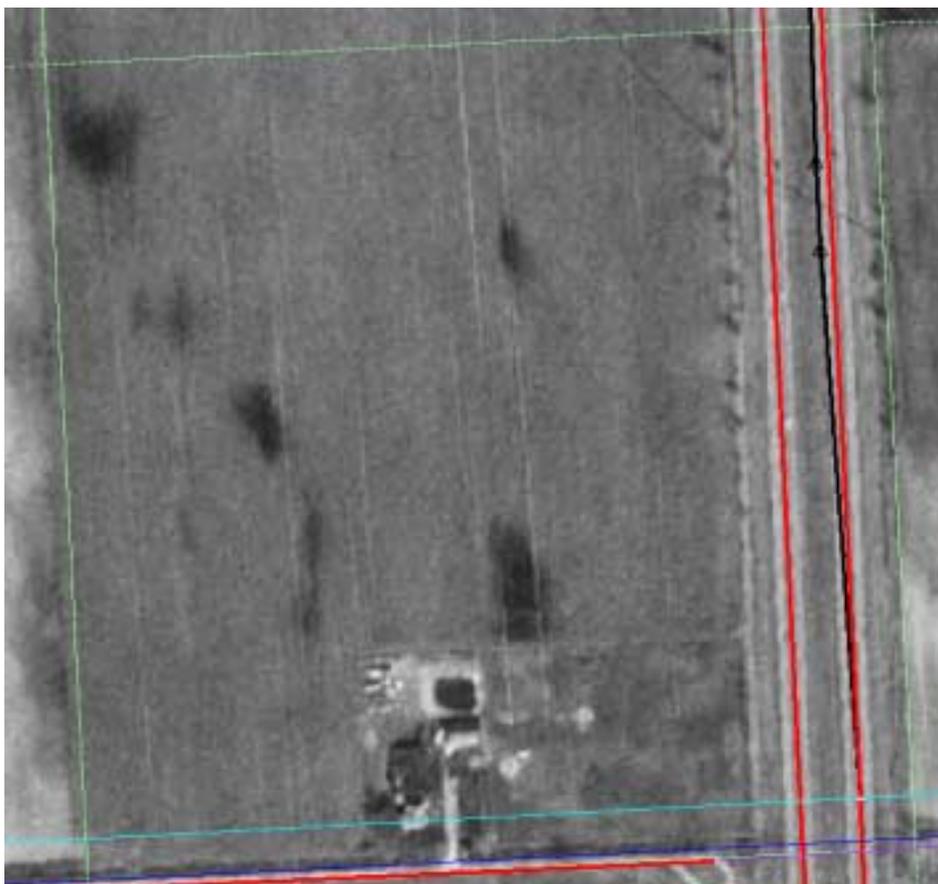
The arcs in the 40 acre view were repositioned. The FCC code was changed to F13 and the SYM was changed to 12. **(Helpful Hint:** Always change the SYM so you know that the arc was reviewed and fixed.)

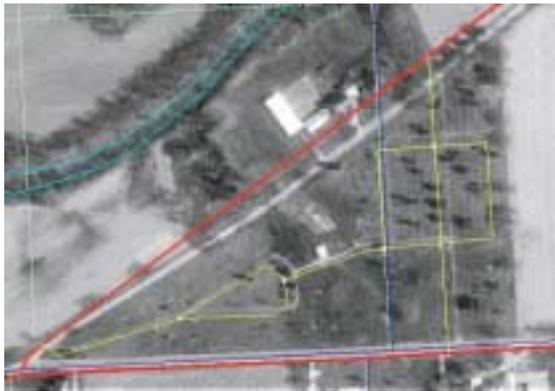
A thin yellow line represents a feature that was originally classified as a road feature in MIRIS or TIGER, but does not match any of the criteria used to classify framework roads. These features are not positionally accurate. The road needs a different FCC code.

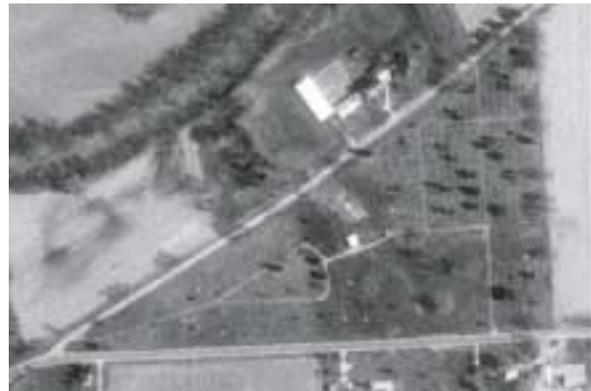
The image above is the digital orthophoto. The shape of the roads indicate that this could be a cemetery or a residential area. **(Helpful Hint:** Viewing the digital orthophoto without the Framework drawn, allows the features to be seen easier.)

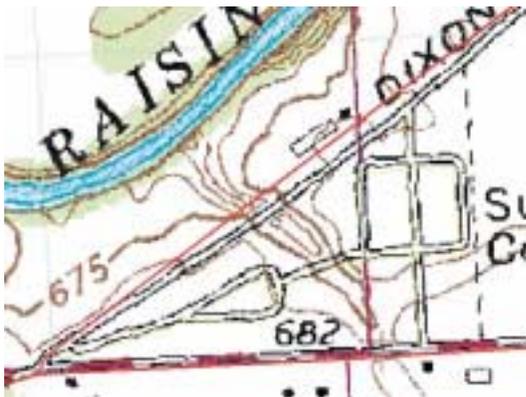
This image shows the framework superimposed on the DRG. Often the DRG will have helpful hints about features found on the imagery that are hard to interpret. The text east of the yellow feature has been cut off in this view, but it indicates this is a cemetery.

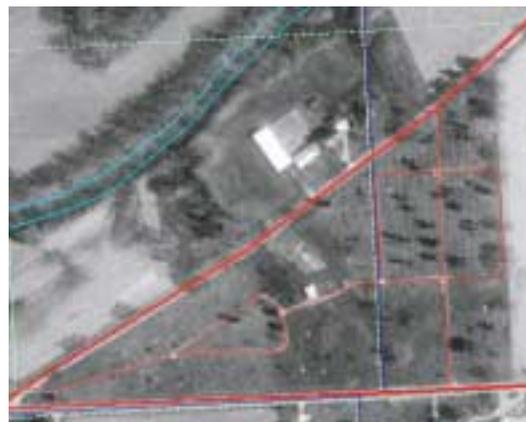
Using clues from the imagery and the DRG, the features were classified as FCC = A51. In addition, the arcs in the above image were repositioned and the SYM was changed to 2.

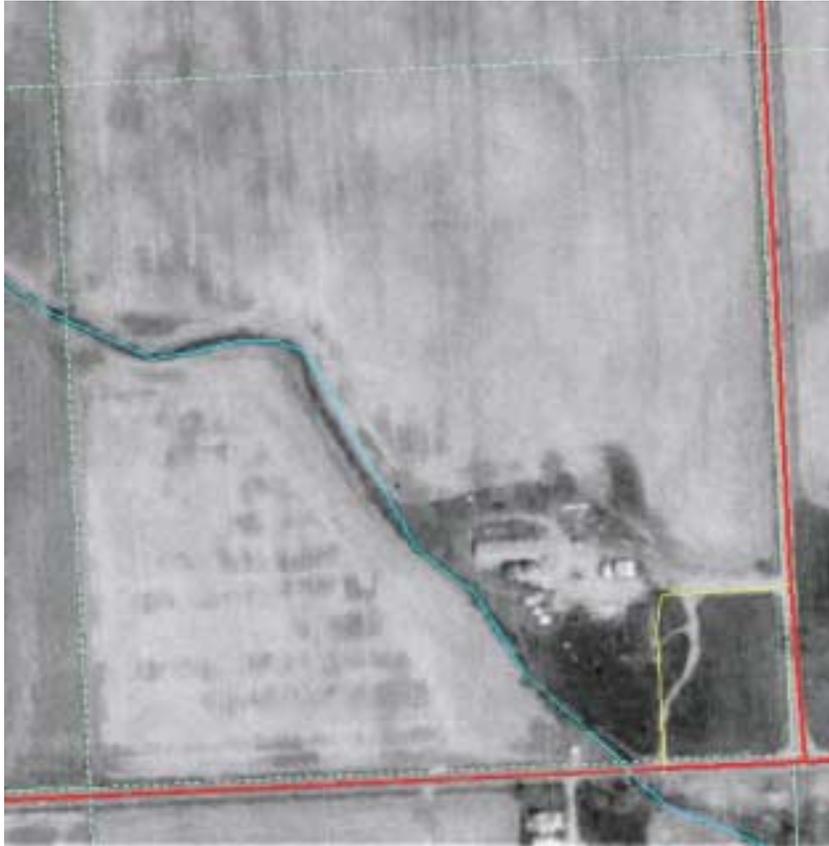
A thin yellow line represents a feature that was originally classified as a road feature in TIGER or MIRIS, but does not match any of the criteria used to classify framework roads. This arc has been flagged yellow indicating the need for investigation during repositioning. While investigating the arc, the Repositioner determined that the yellow arc is not a road feature. However, this arc represent a Census Block boundary. Therefore, the arc could not be deleted.

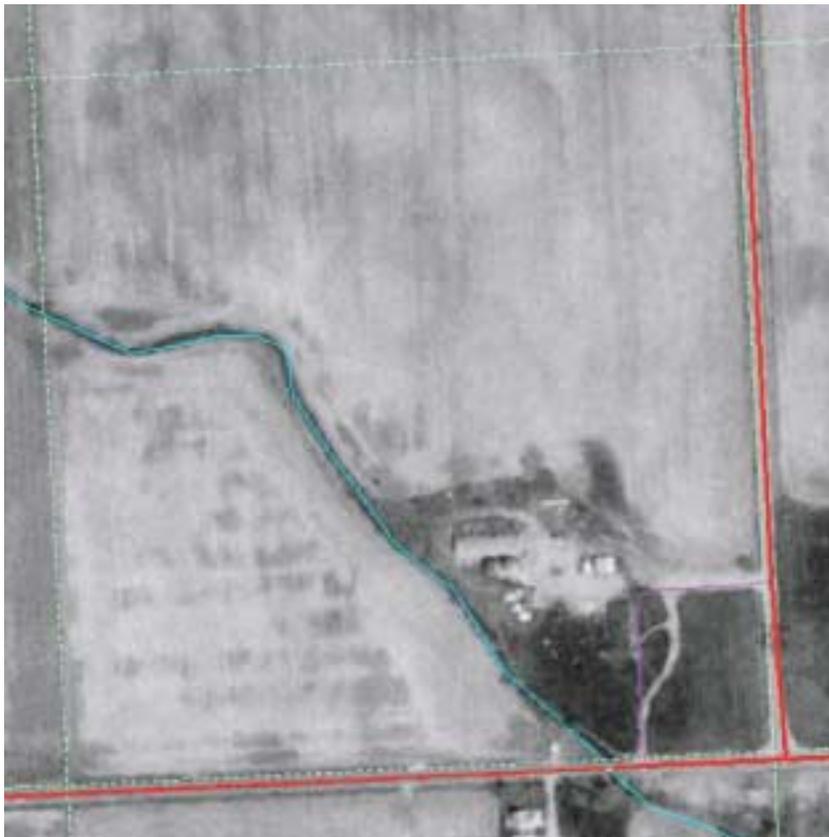
The arcs in the 40 acre view were repositioned. The FCC code was changed to F43 and the SYM was changed to 12. **(Helpful Hint:** Always change the SYM so you know that the arc was reviewed and fixed).

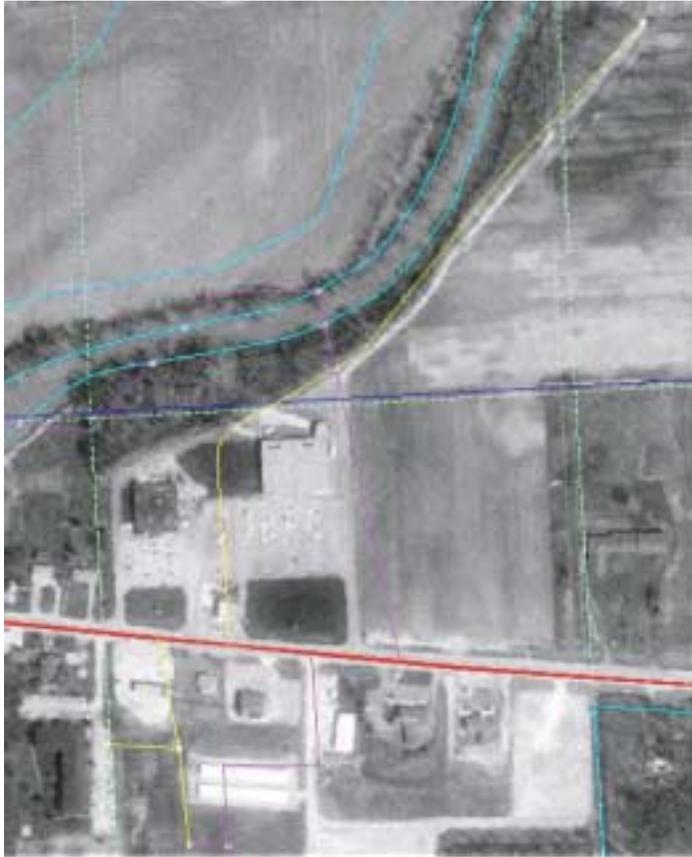
A thin yellow line represents a feature that was originally classified as a road feature in MIRIS or TIGER, but does not match any of the criteria used to classify framework roads. There are two groups of yellow roads in this image. The yellow road to the north appears to be a road to a non-residential area. The roads to the south appear to access a residential area. The features are not positionally accurate and the FCC needs to be changed.

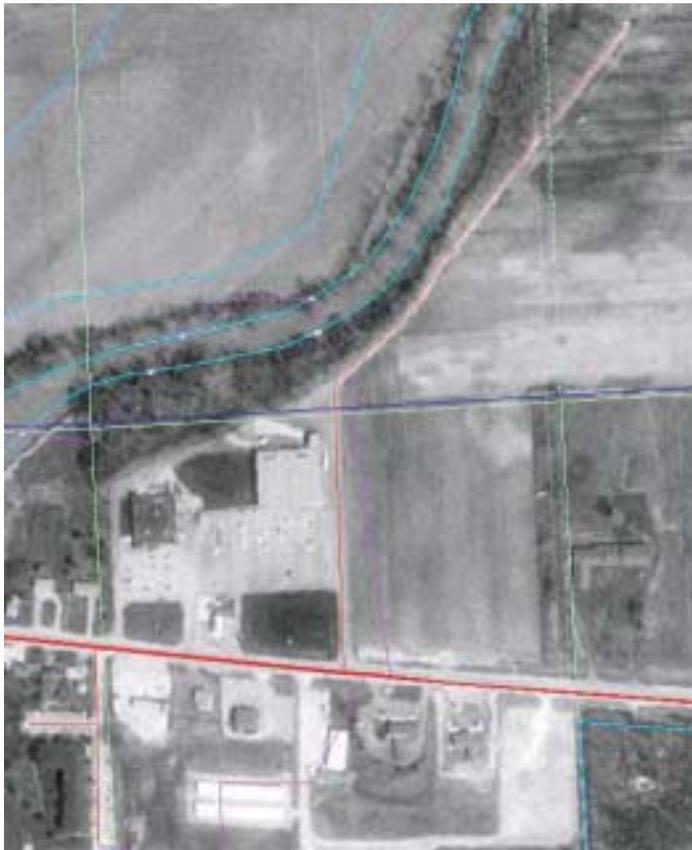
The arcs in this image have been repositioned. The road features to the north were classified as FCC = A52 and the SYM was changed to 2. The roads to the south were classified as FCC = A55 and the SYM was changed to 2. For an in depth explanation of the procedure used to reposition the nonvisible features, see page HXXX.

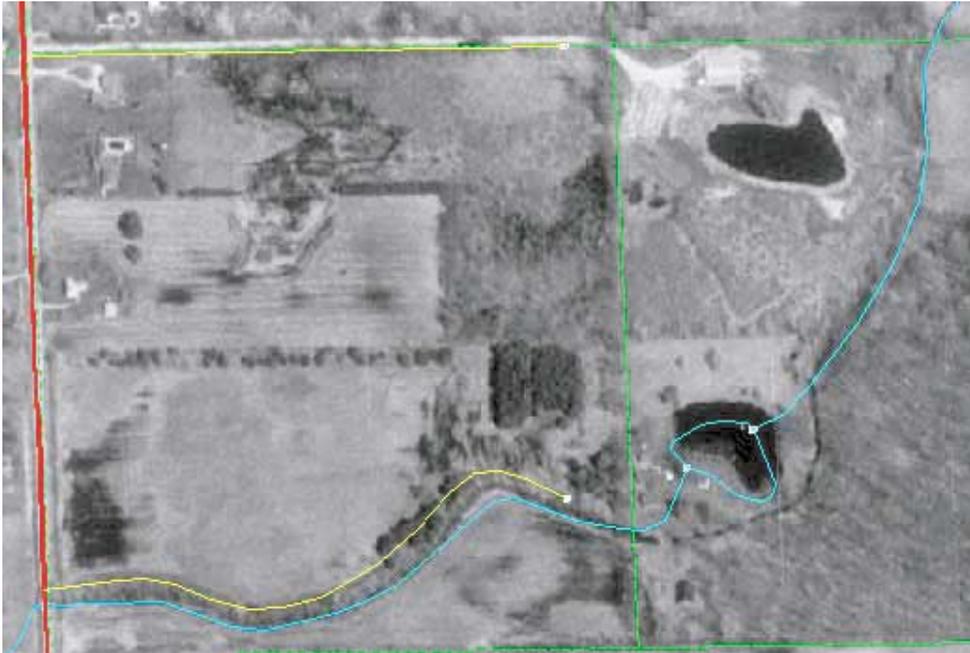
A thin yellow line represents a feature that was originally classified as a road feature by TIGER or MIRIS, but does not match any of the criteria used to classify framework roads. There are two yellow features seen in this example. The northern yellow feature is clearly seen on the image and can be easily repositioned and reclassified. However, the southern yellow feature is undetectable. Therefore it cannot be repositioned or classified as a road.

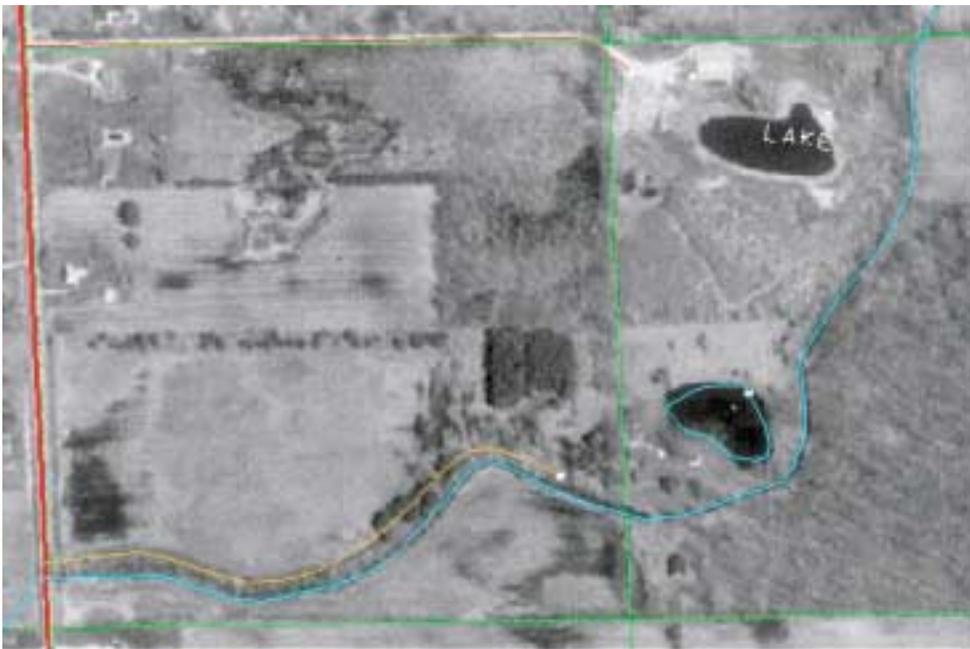
This image is the area after it has been repositioned. The northern feature was repositioned and classified as a FCC = A56. The symbology was changed to 2. The southern feature was not repositioned, but it was reclassified as a FCC = X00. This FCC code is given to features that have been researched during repositioning, but feature type is still unknown. X00 is a flag indicating the feature needs to be reviewed and fixed during framework maintenance. For an in depth explanation of the procedure used to reposition the hydrography, see page HXXX.

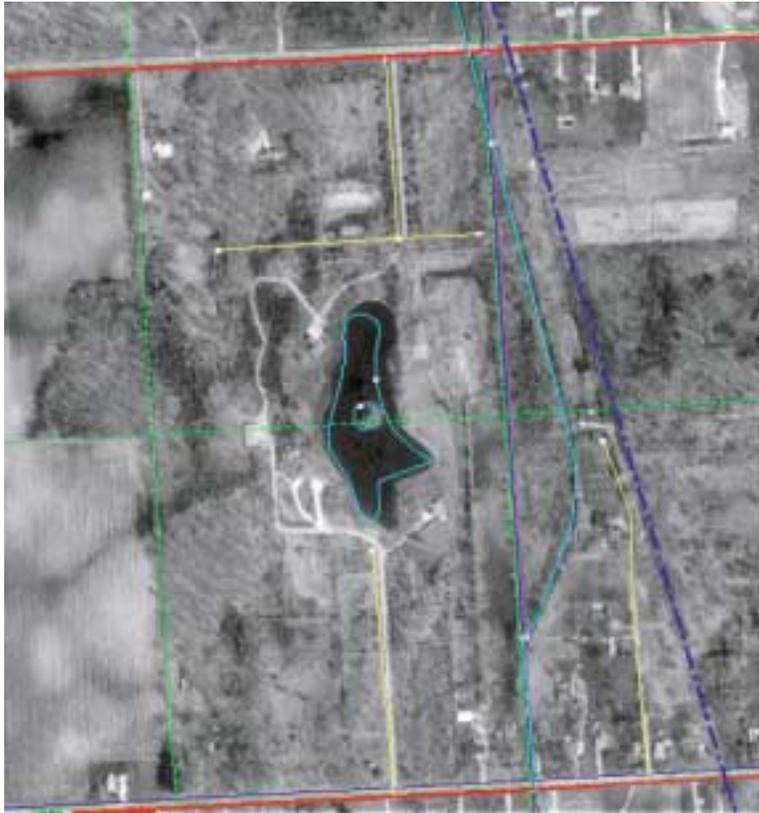
A thin yellow line represents a feature that was originally classified as a road feature by MIRIS or TIGER, but does not match any of the criteria used to classify framework roads. There are a few houses and driveways visible on the imagery indicating that this is a newly developed residential area. There is not a PR or road name on the yellow arc feature. This allows the Repositioner to connect the yellow features and reposition them to follow the road features seen on the imagery.

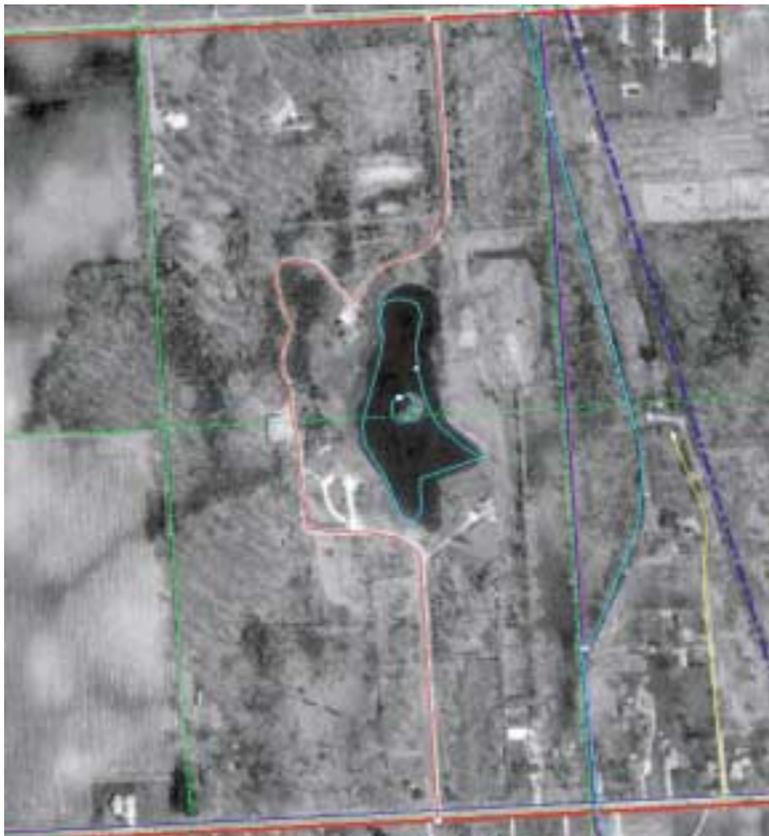
This image shows the area after it has been repositioned. Notice the three yellow features have been combined into one road feature. The feature was classified as FCC = A53 and SYM was changed to 2.

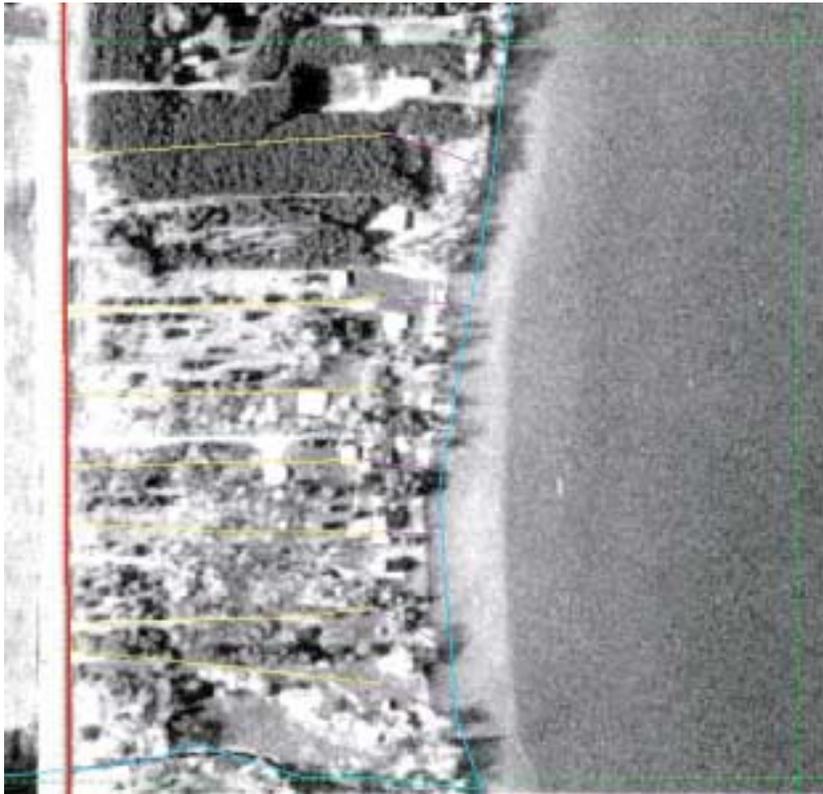
The image to the left is a group of private roads and private driveways leading to a residential area. It is difficult to determine which Framework road matches the imagery. The roads in the area should be repositioned as accurately as possible. However, do not spend a large amount of time.

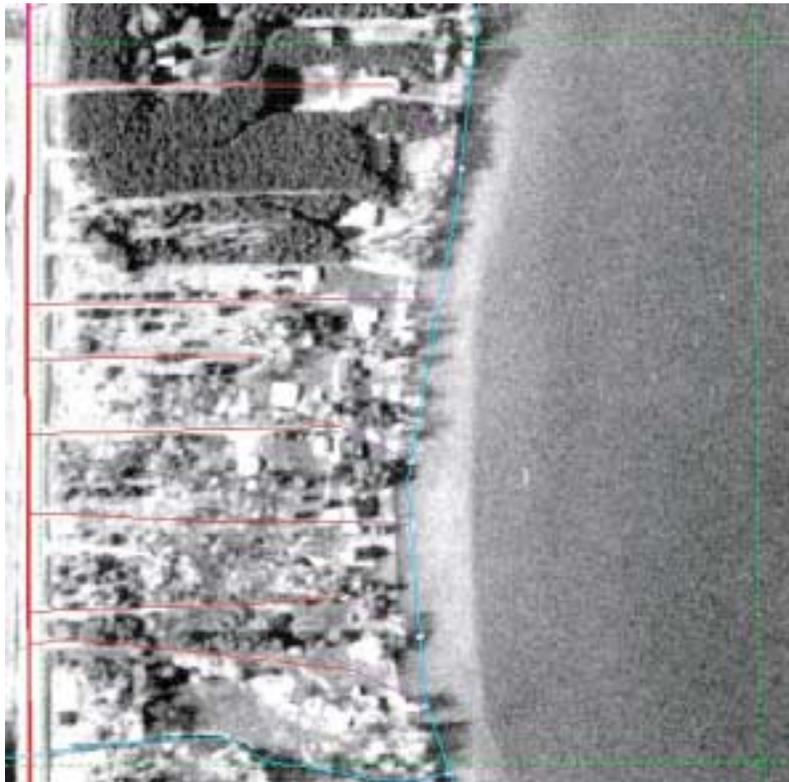
This image shows the area after it has been repositioned. The roads were reclassified as FCC = A53 and the symbology was changed to 2. (**Helpful Hint:** Always change the sym so you know the arc was reviewed and fixed.)

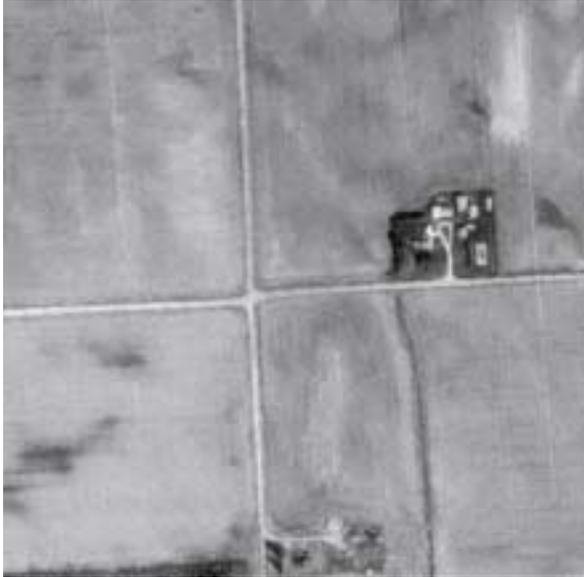
A jog must measure a distance of at least seven meters from centerline to centerline. By measuring the centerline distance and using their judgment on the angle of the intersection, the Repositioner decided that this intersection does not jog.

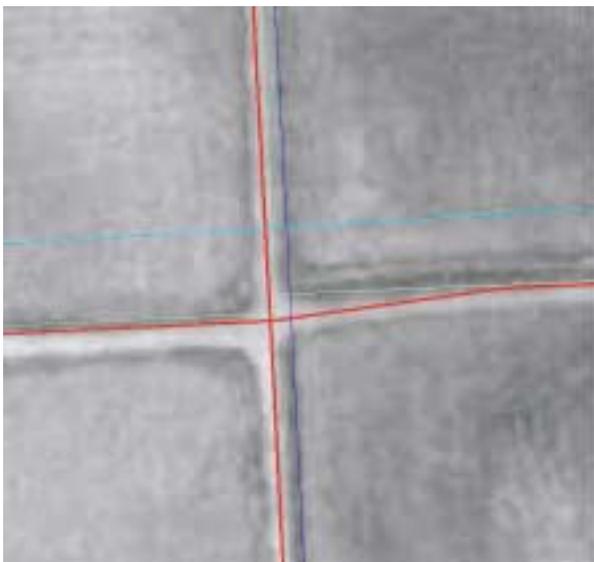
This image shows that the topology of the roads in framework is correct, but the roads need to be repositioned.

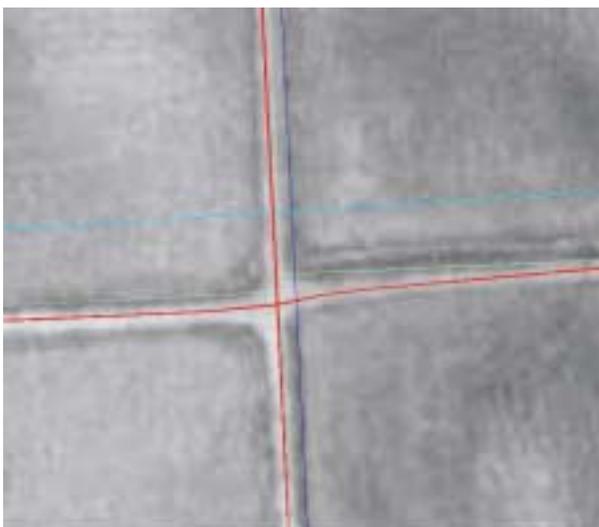
This image shows the area after it has been repositioned. The topology of the intersection has not been changed, but the general shape has been smoothed out.

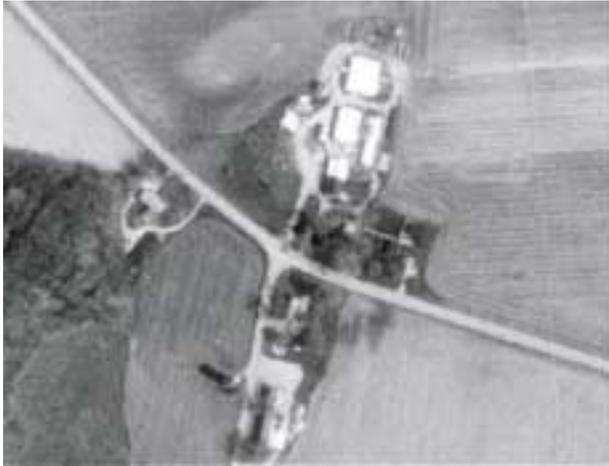
The image above is an example of a fanned intersection. A fanned intersection is a three approach intersection with no defined turn channels. Often, fanned intersections are located on rural dirt roads.

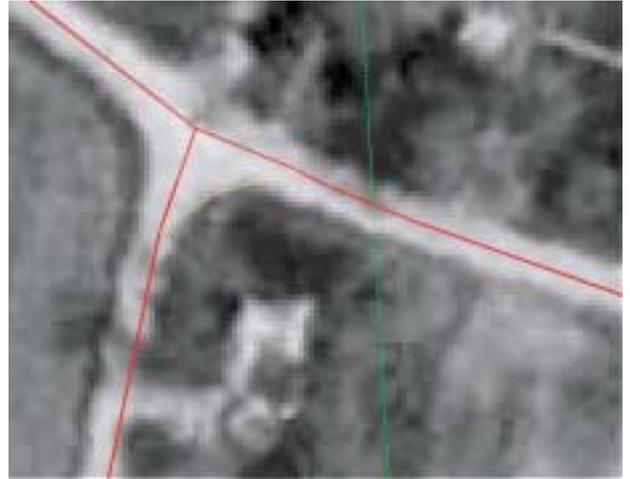
The road arcs forming the intersection should be positioned to follow the centerline of the roads. Often the framework coverage will have an extra arc (the yellow arc seen in this image) representing the fanned shape. This arc should be deleted from the coverage. In this situation, the pseudo nodes should not be removed because the road has address ranges that need to be preserved.

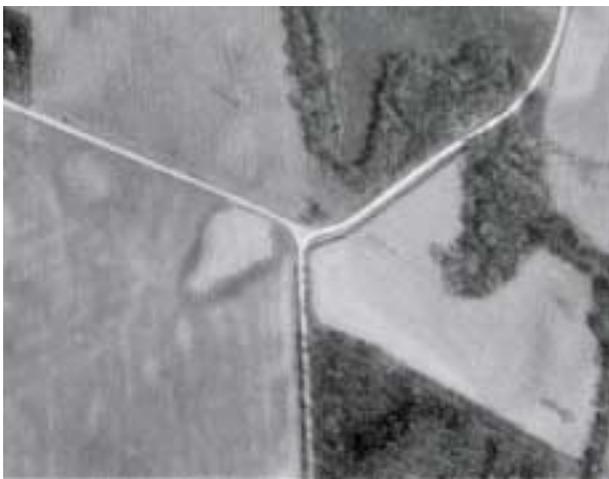
The image above is an example of a cutoff intersection. Like a fanned intersection, the cutoff intersection is a three approach intersection. However, this intersection has turn channels defined by the dark area in the center of the intersection.

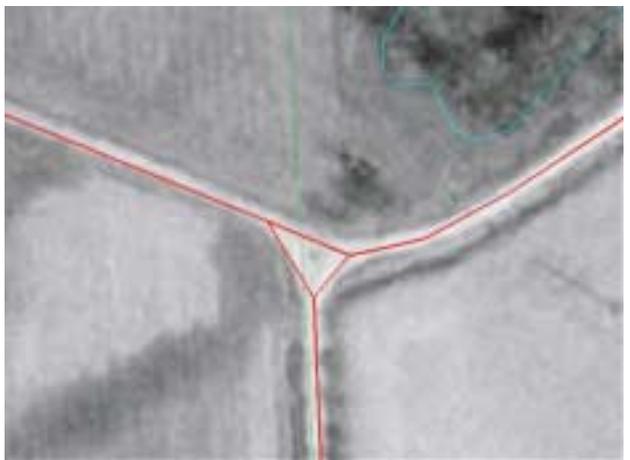
There should be three arcs forming a triangle representing the cutoff. In addition, there should be three PRs at this intersection. If there are not three PRs, flag the intersection with a ROAD annotation.

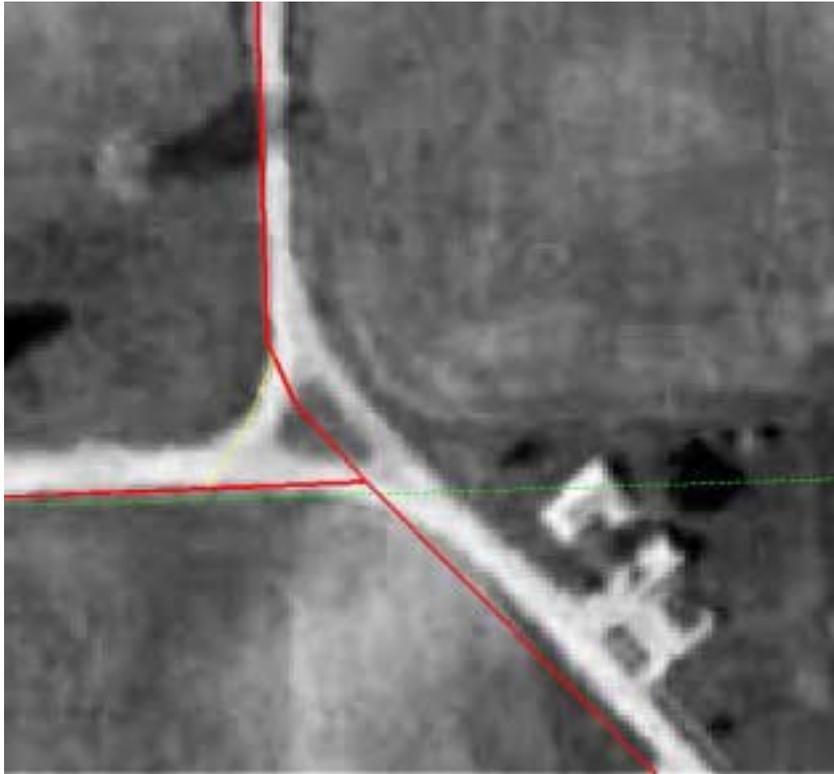
There is a visible grassy area in the center of this intersection indicating that this is a cutoff intersection. There should be three PR'd road features forming the cutoff intersection. In this example, the thin yellow arc does not have a PR. During repositioning, there will be no PRs added. However, this arc should be flagged so the area is reviewed during framework maintenance.

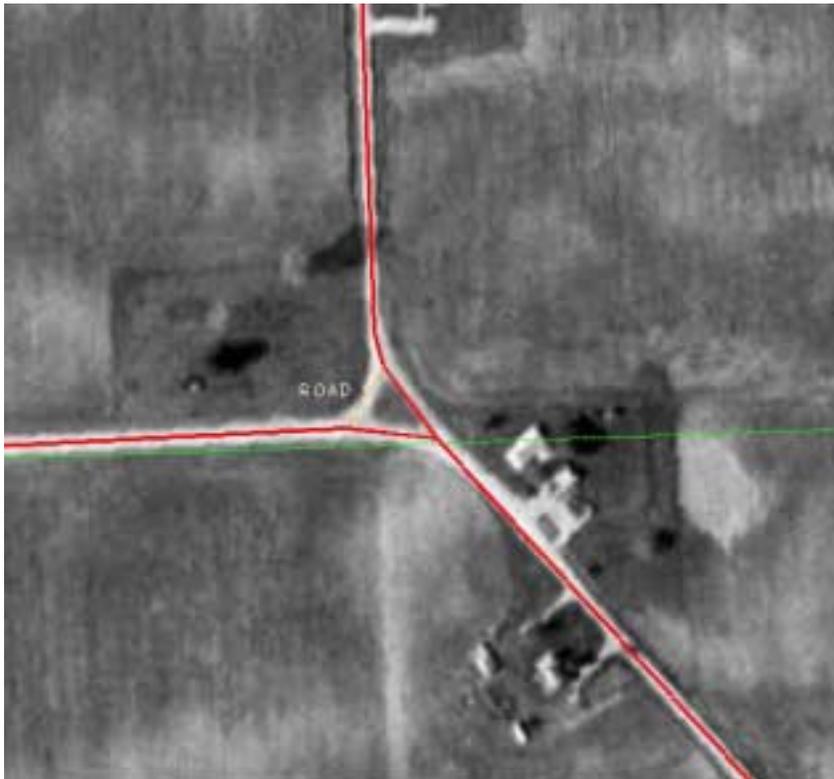
This image shows the area after it was repositioned. The arcs have been repositioned to follow the center line of the roads. A ROAD annotation was placed by the yellow arc, flagging it for investigation during framework maintenance.

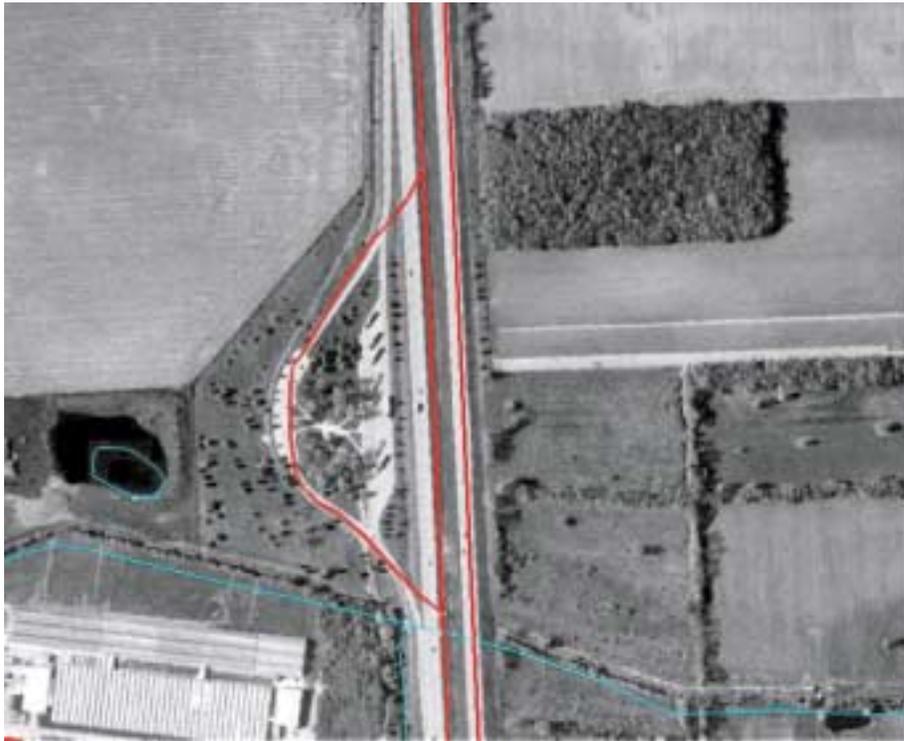
The example to the left is a rest area found in Framework. A rest area is always represented by two road features. This rest area is incorrect. The road feature representing the truck/trailer lane is missing. New features are not added during repositioning. If a feature is seen on the imagery, it is flagged to be reviewed during framework maintenance.

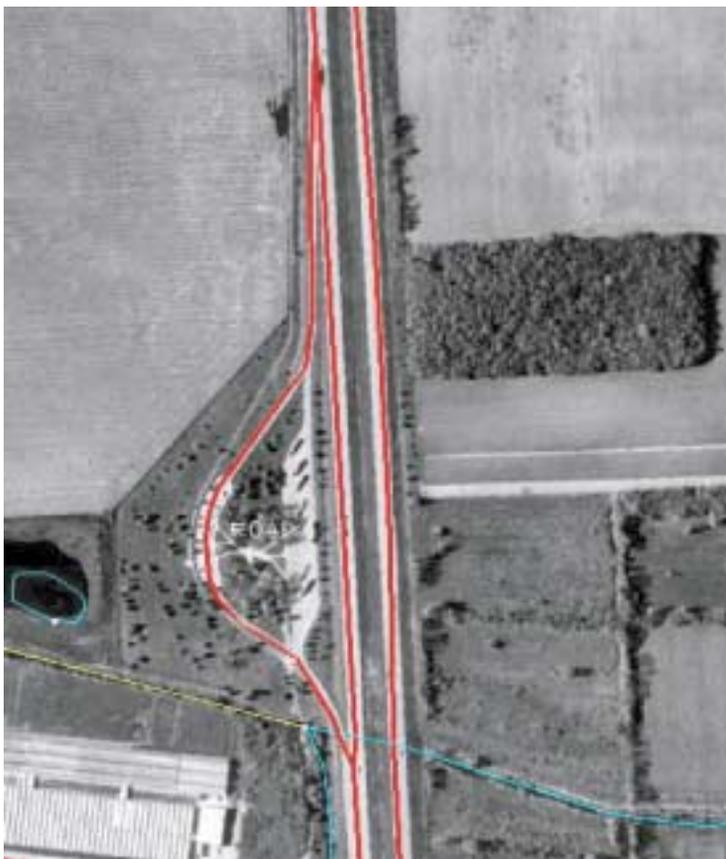
The image to the left is the rest area after it has been repositioned. The rest area was marked with a ROAD annotation, flagging the area to be reviewed during Framework maintenance.

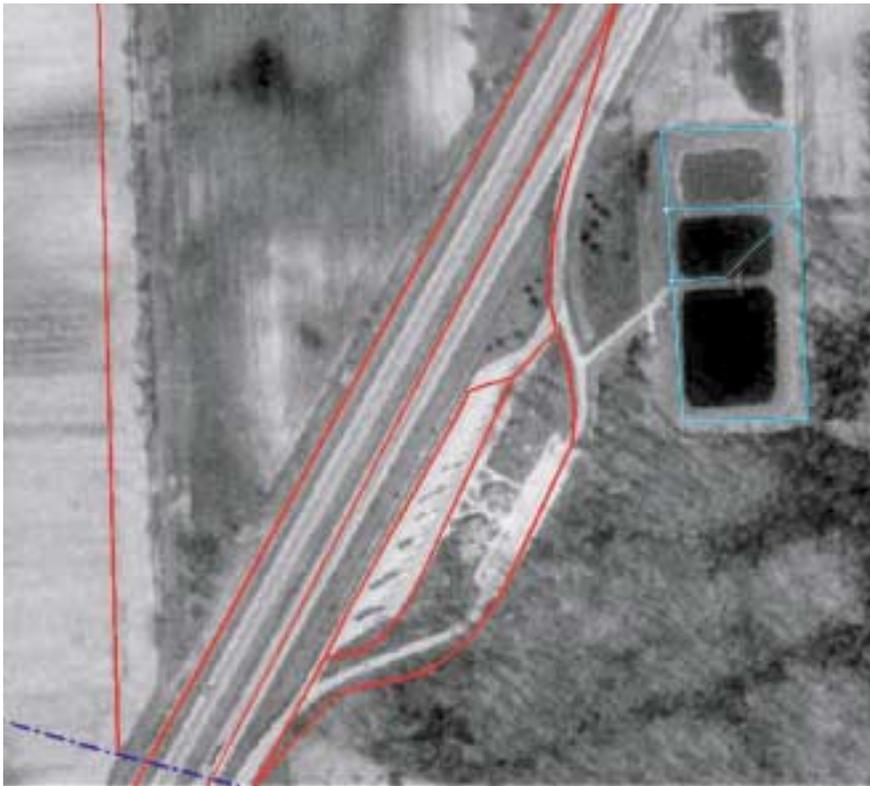
The example to the left is a rest area found in Framework. A rest area is always represented by two road features. This rest area is incorrect. There are two road features representing the truck/trailer lane. Road features with PRs are not being removed during repositioning. If an extra feature is in the coverage, it is flagged to be removed during framework maintenance.

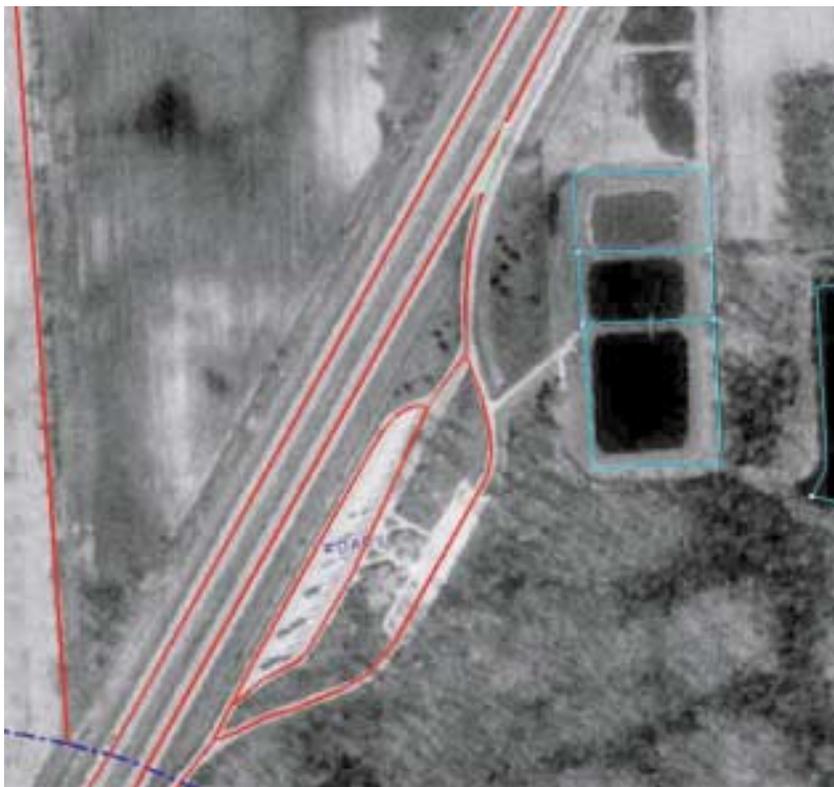
The image to the left is the rest area after it has been repositioned. The rest area was marked with a ROAD annotation, flagging the area to be reviewed during Framework maintenance.

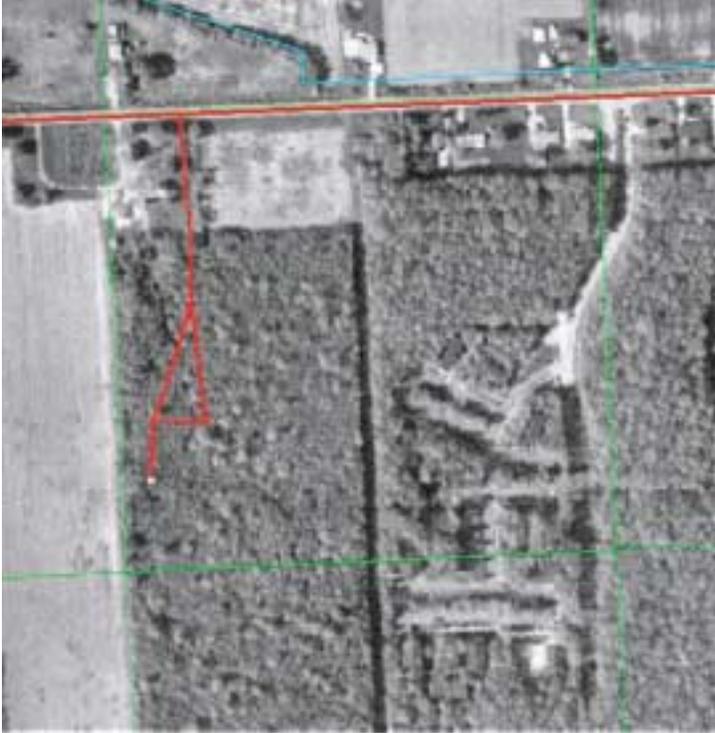
The image to the left is an example of a group of road features that resembles an area on the imagery. However, it is questionable. In order to reposition these arcs, they would be moved approximately 300 meters to the east. The shape and lengths of the Framework road features would be changed drastically. There is not enough information here to make a decision. Therefore, the area should be flagged with a ROAD annotation so that it can be investigated during Framework maintenance.

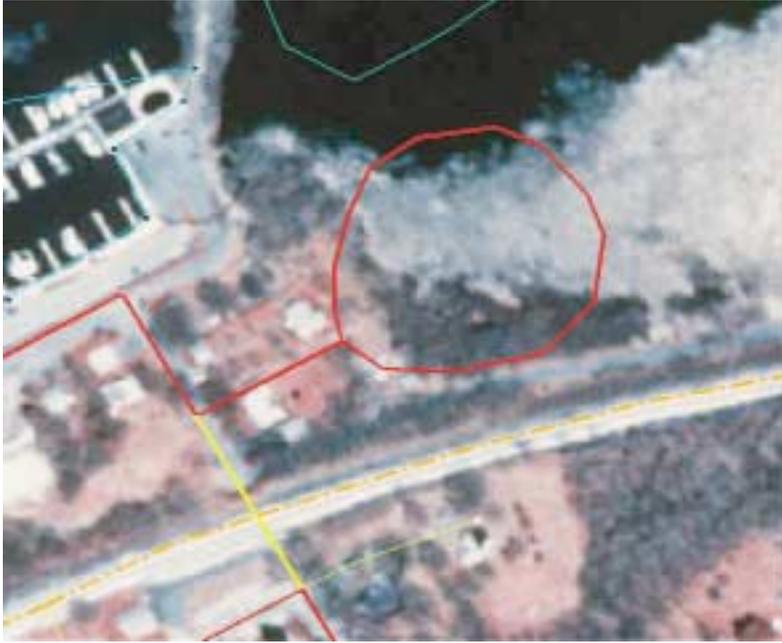
In this example, a Framework road feature is positioned in the water. However, there is no feature seen on the imagery to reposition the road. In this situation, the Repositioner must reshape the feature so that it does not extend into the water, while preserving the shape of the road.

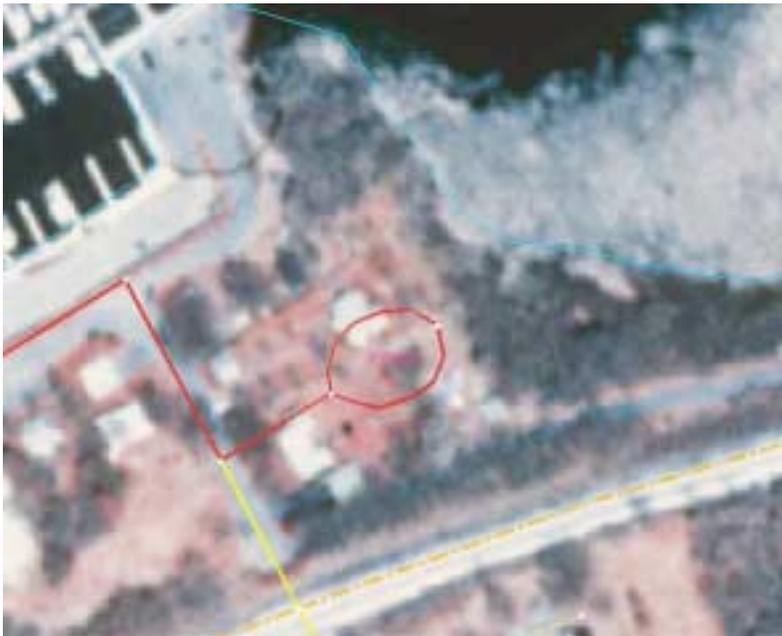
This image shows the Framework coverage after it has been repositioned. The road intersection has not changed, but the feature was reshaped. A ROAD annotation was added, so that the feature can be checked during Framework maintenance.

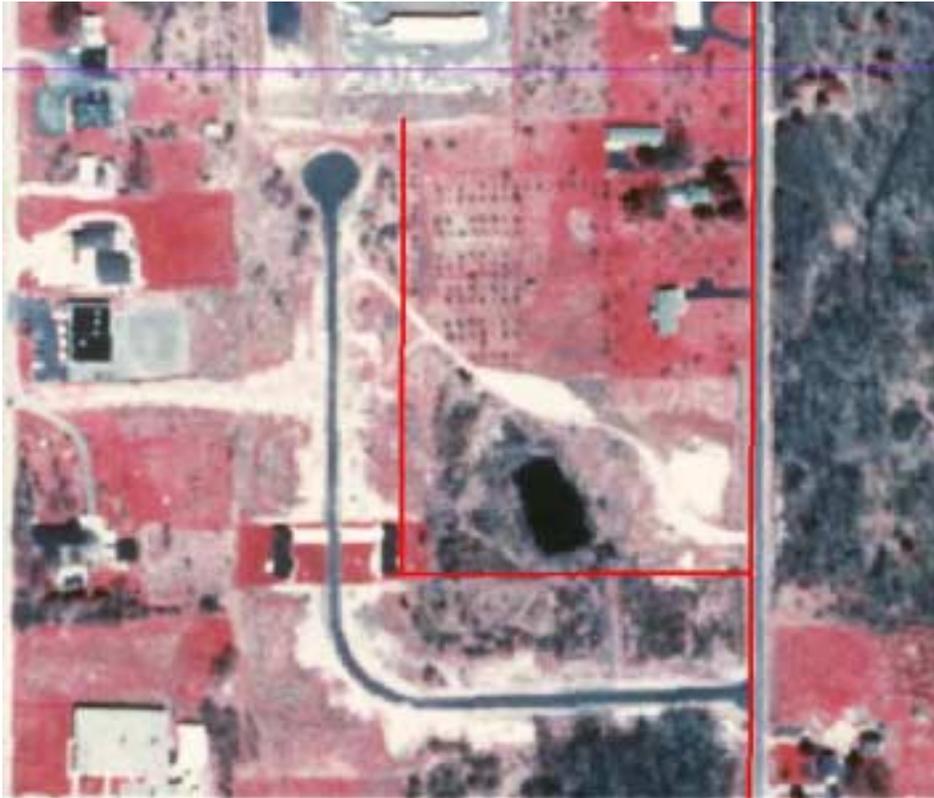
The road seen in this example is a cul de sac. The road needs to be repositioned to follow the feature seen on the image. However, the road will not be shaped to follow the cul de sac. If there was a grassy area in the center of the cul de sac in which houses could be built, then the circle would be created.

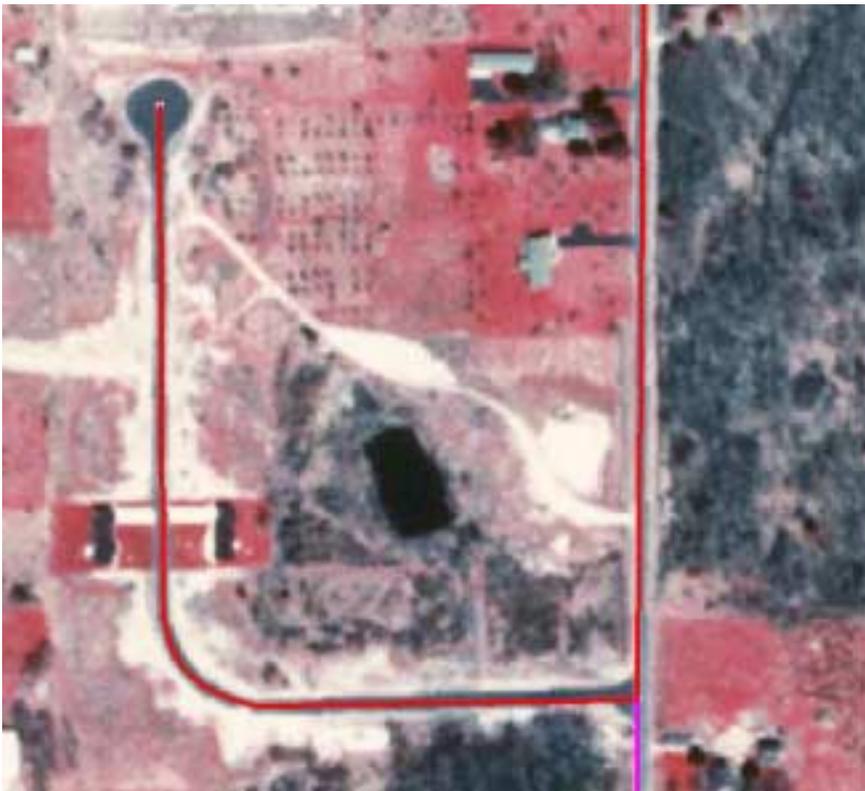
This image shows the road after it has been repositioned. The road has been moved to the southwest and the corner was reshaped from a 90 degree angle to a soft curve. Notice that the road has not been shaped around the cul de sac. The end of the road was positioned in the center of the cul de sac.

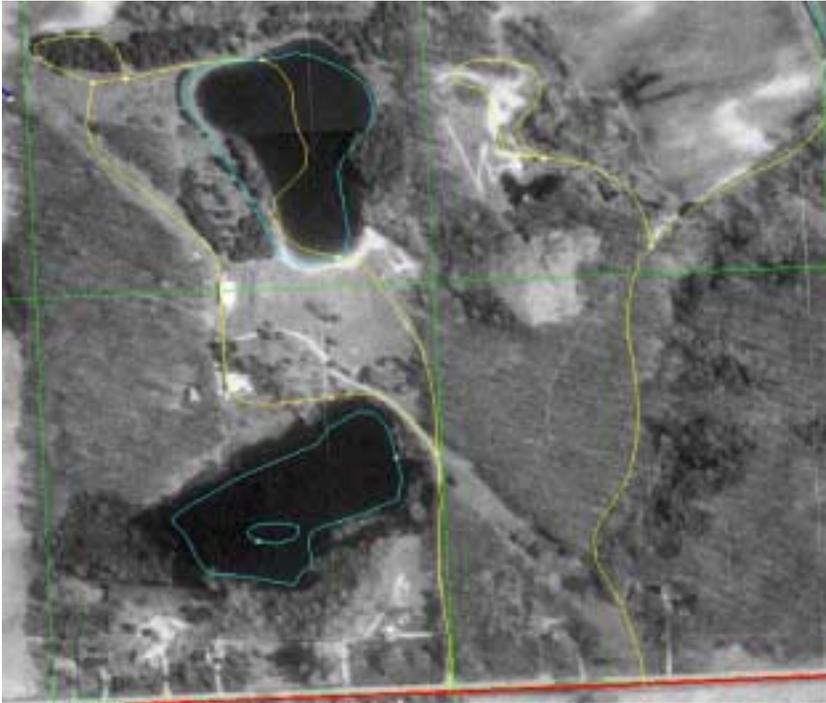
The thin yellow lines indicate that the features were unable to be classified with a FCC code and need further investigation. In the image to the left, the yellow arcs are two-track features that are not correctly positioned. Most of the two-tracks can be seen on the imagery. However, a few of the two-tracks are undetectable and cannot be repositioned. Notice, the two-track cuts through the water feature.

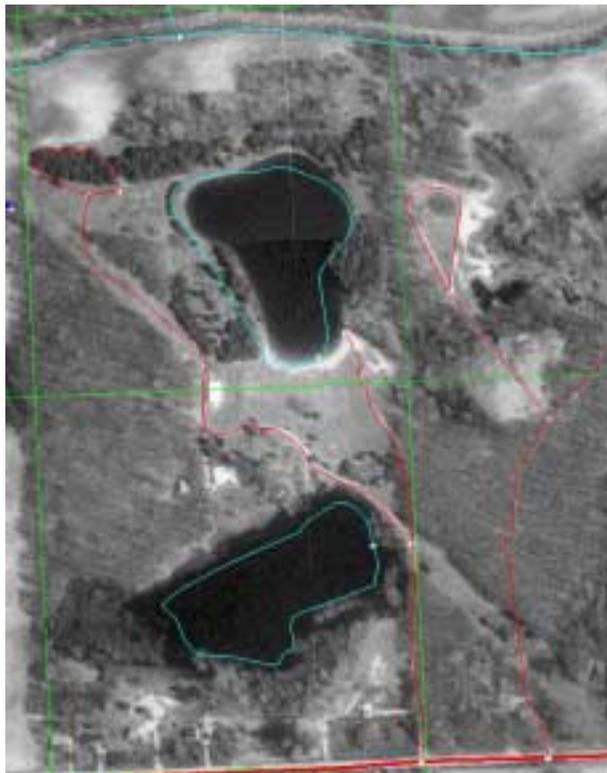
This image shows the framework coverage after it was repositioned and reclassified. The yellow features were classified as FCC = A56 and the SYM was changed to 2. The two-track feature that ran through the lake was deleted. The arc that was connected to the water was disconnected and the pseudo nodes were removed. For an in depth explanation of the procedure used to reposition the hydrography, see page HXXX.

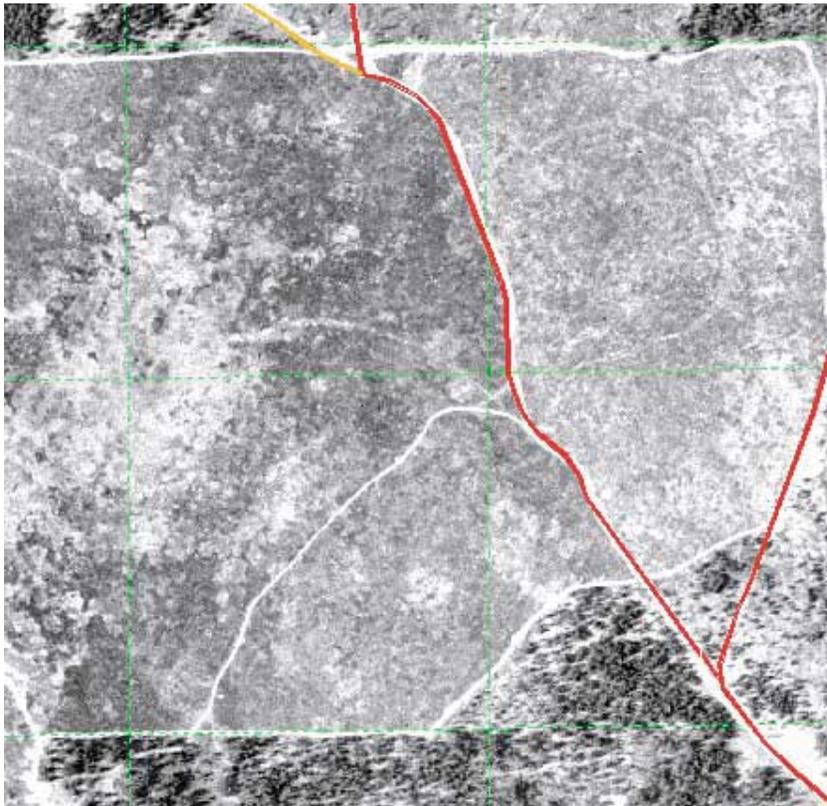
During repositioning, new features will not be added. However, in many rural areas there are two-tracks seen on the imagery which are not represented in Framework. These two-tracks need to be marked with a TWOTRACK annotation, flagging the area for investigation during Framework maintenance.
