ROAD REPOSITIONING ISSUES

January 31, 2001

The following pages are examples of Road repositioning issues encountered in the Michigan Geographic Framework. They are presented here in draft form for consideration by Framework users and partners. Please review these examples and feel free to provide feedback to:

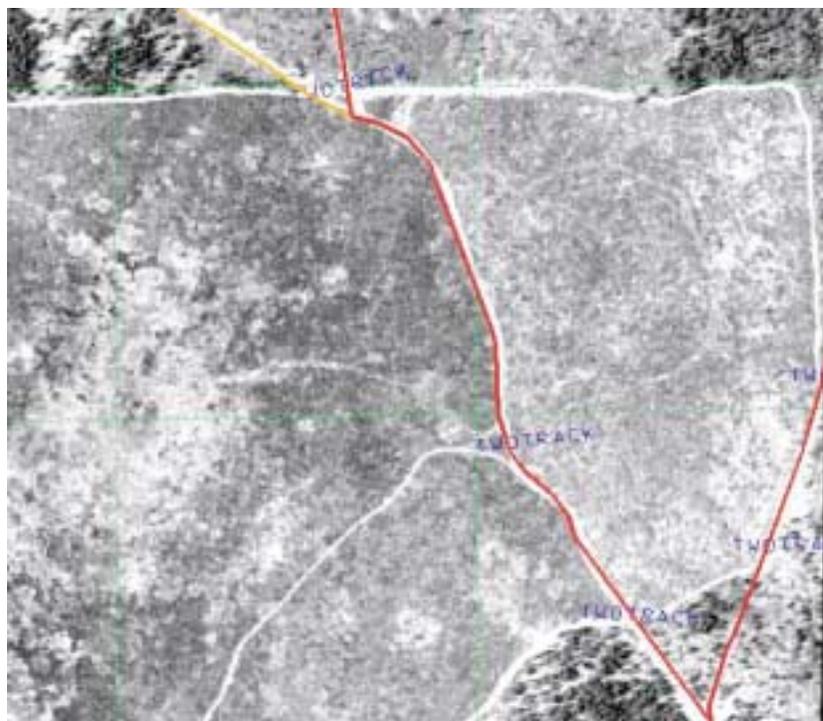
An annotation is added where a two-track intersects a PR'd road. This image shows the Framework coverage after the TWOTRACK annotations were added. The road features seen in this example have not yet been repositioned.

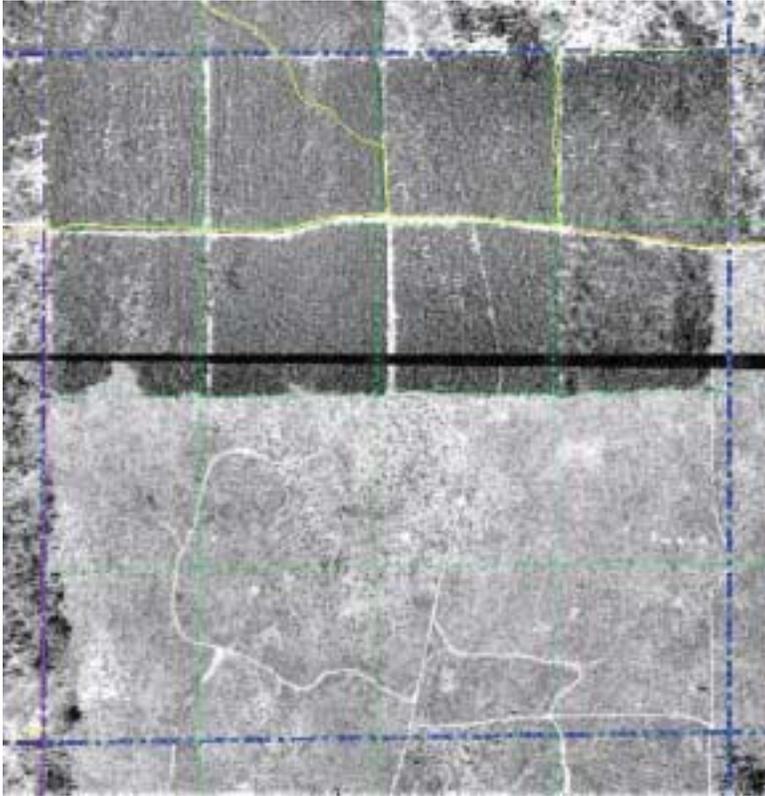
The image to the left is a view of an entire section of a Framework coverage. The thin yellow lines indicate that the features were unable to be classified with a FCC code and need investigation. During repositioning, new features will not be added. However, in many rural areas there are two-tracks seen on the imagery which are not represented in Framework. These two-tracks need to be marked with a TWOTRACK annotation, flagging the area for investigation during Framework maintenance.

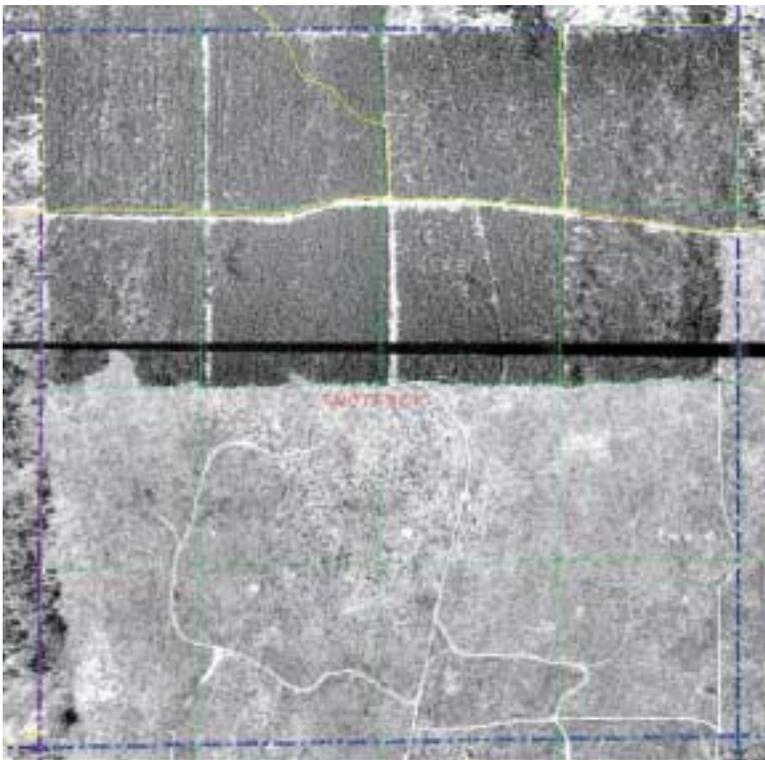
An annotation is added where a two-track intersects a PR'd road. However, this network of two-tracks does not have an intersection with a PR'd road. Therefore, a TWOTRACK annotation is placed in the center of the section. This indicates that the entire section needs to be reviewed during Framework maintenance. At that time, the appropriate two-track features will be added to the Framework coverage.

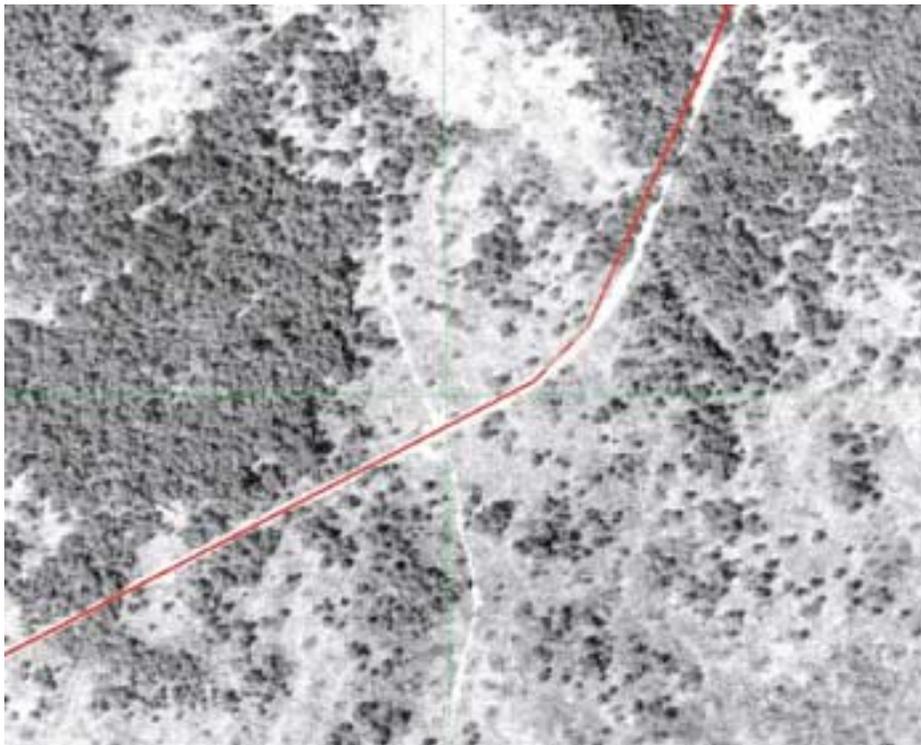
During repositioning, new features will not be added. However, in many rural areas there are two-tracks seen on the imagery which are not represented in Framework. These two-tracks need to be marked with a TWOTRACK annotation, flagging the area for investigation during Framework maintenance.

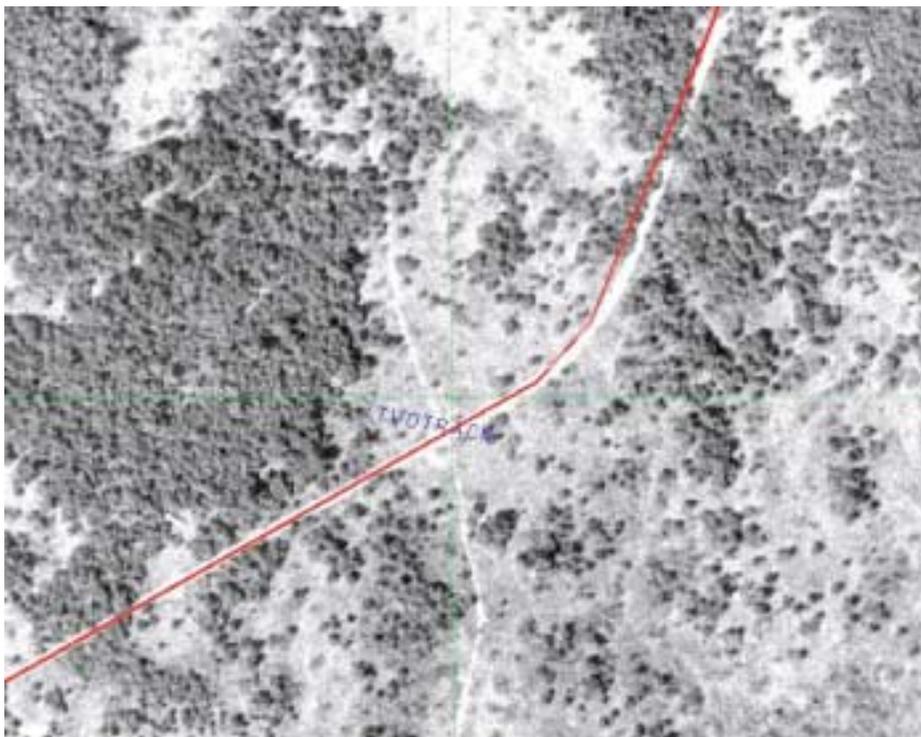
An annotation is added where a two-track intersects a PR'd road. This image shows the Framework coverage after the TWOTRACK annotations were added. The road features seen in this example have not yet been repositioned.

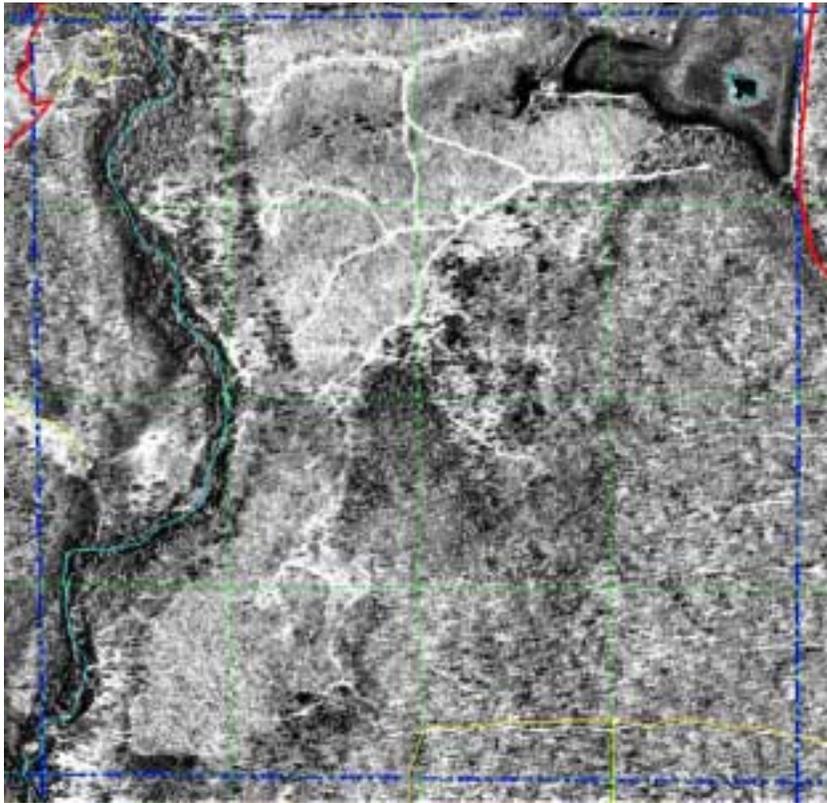
The image to the left is a view of an entire section of a Framework coverage. The thin yellow lines indicate that the features were unable to be classified with a FCC code and need investigation. During repositioning, new features will not be added. However, in many rural areas there are two-tracks seen on the imagery which are not represented in Framework. These two-tracks need to be marked with a TWOTRACK annotation, flagging the area for investigation during Framework maintenance.

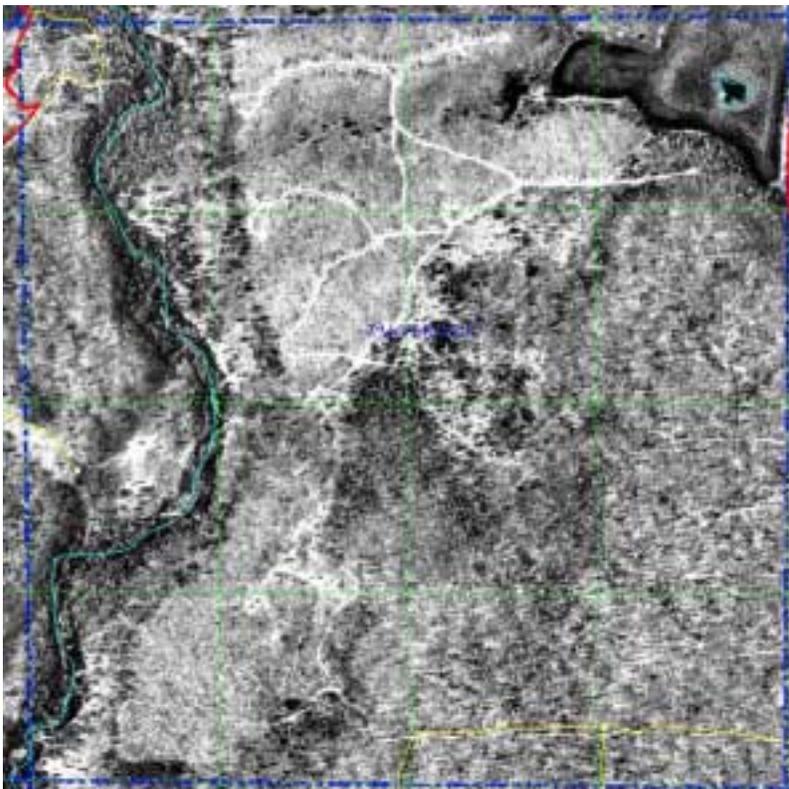
An annotation is added where a two-track intersects a PR'd road. However, this network of two-tracks does not have an intersection with a PR'd road. Therefore, a TWOTRACK annotation is placed in the center of the section. This indicates that the entire section needs to be reviewed during Framework maintenance. At that time, the appropriate two-track features will be added to the Framework coverage.

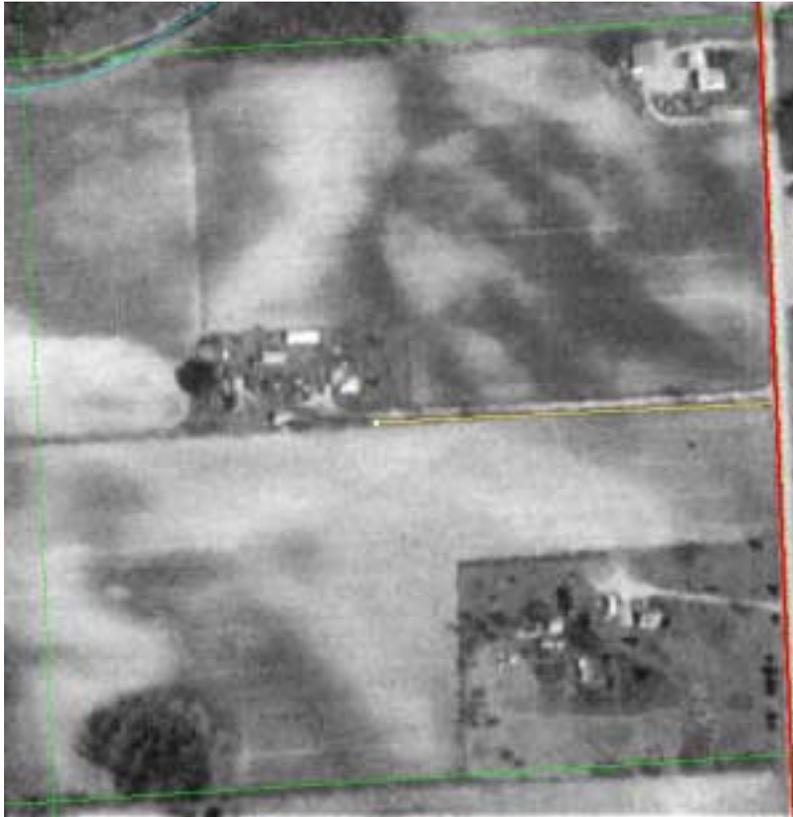
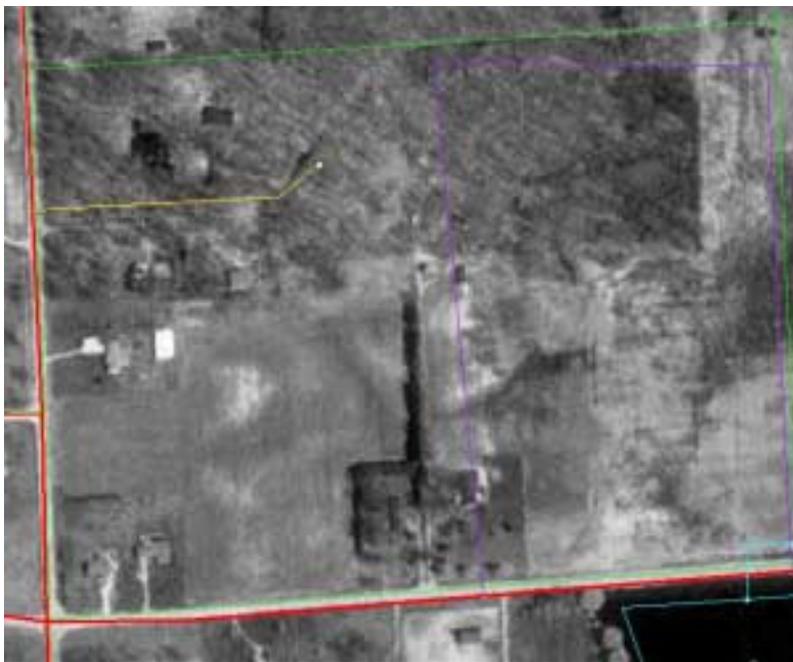
Both of the images seen on this page are examples of road features that appear to be private driveways. A thin yellow line indicates that a feature was unable to be classified with a FCC and needs further investigation. The level = 4, this indicates that the features originally came from MIRIS. MIRIS classified them as local, minor, residential streets. There are several of these types of dead end road features in every Framework coverage. In the top example, the feature is a private driveway. This could be classified as FCC = A53 or should it be deleted? In the bottom example, the road feature appears to have more than one residence. During repositioning, this feature would be repositioned and classified FCC = A55.
