Schoolcraft County Recession Rate Study 2018

Prepared by Kate Lederle, Environmental Quality Specialist, High Risk Erosion Area Program, Great Lakes Shorelands Unit, Surface Water Assessment Section, Water Resources Division, Michigan Department of Environmental Quality
Lansing, Michigan

December 4, 2018

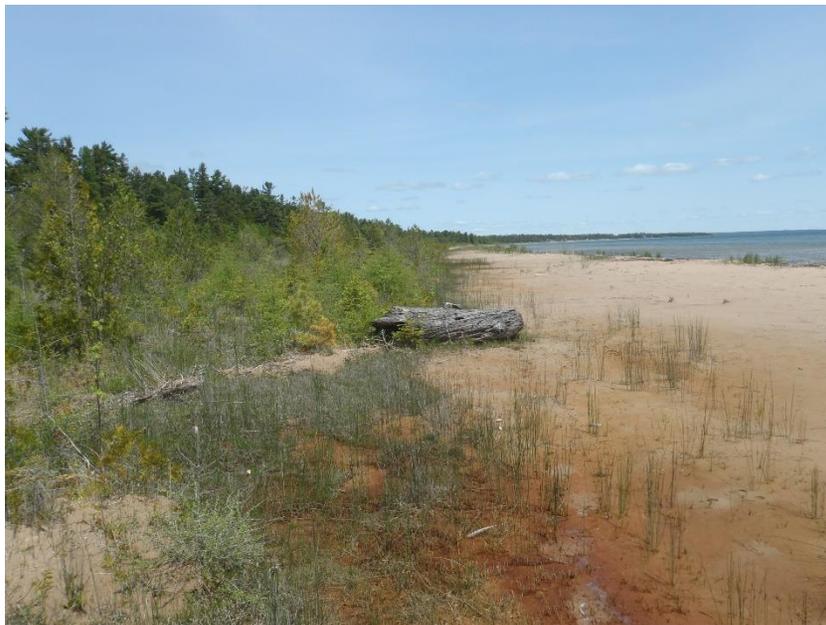
The existing area at the Thompson Creek MDNR Access was receding at a rate of 1.9 feet per year in 1985. The current study determined the area is no longer eroding at this rate but is accreting at approximately 0.5 foot per year. The shoreline is a coastal wetland with the invasive plant species, *Phragmites australis*, present.

The study will affect a total of two parcels in the township. The previously designated parcels, 70-008-082-002-00 and 70-008-950-008-00, were found to not be eroding at an average annual rate of one foot or greater. The high risk erosion area designation will be removed from the parcels. The parcel owners will no longer be required to obtain a permit for new structures, or additions, to be set back a specific distance from the erosion hazard line per Part 323.
