Maintenance Memorandum

Subject: **Guidance for Repair of Damaged Mailboxes**

Standard Mailbox Installation

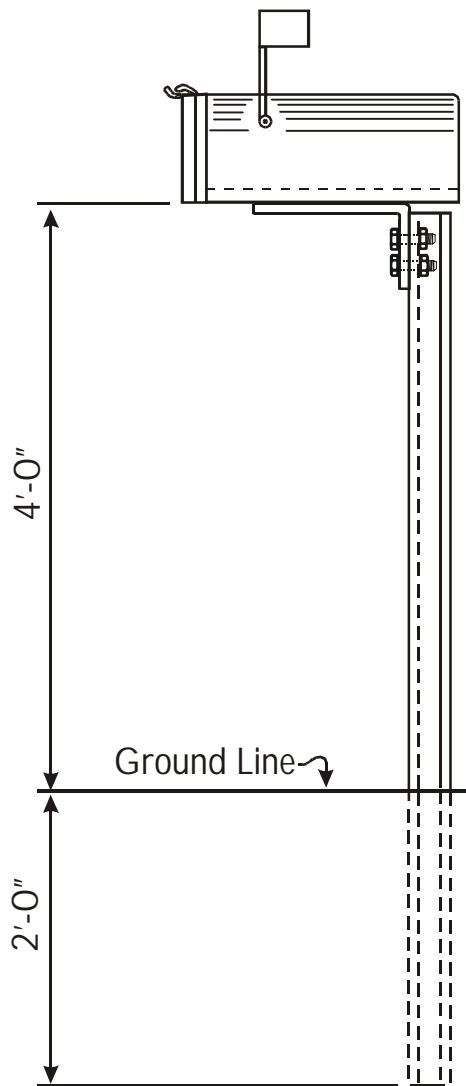
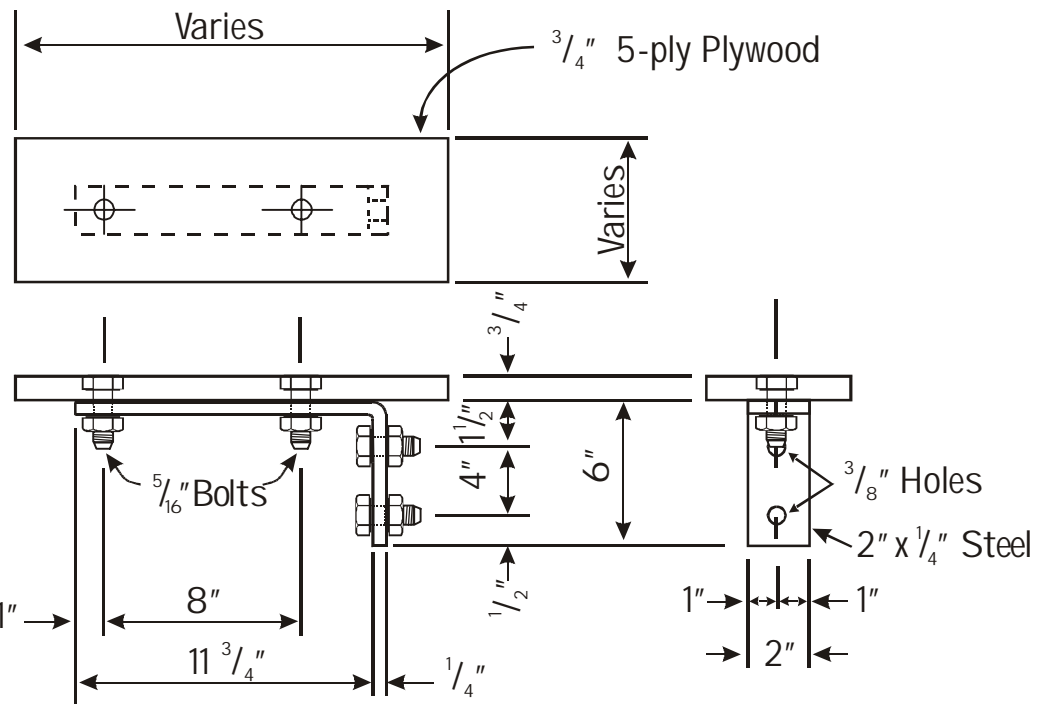
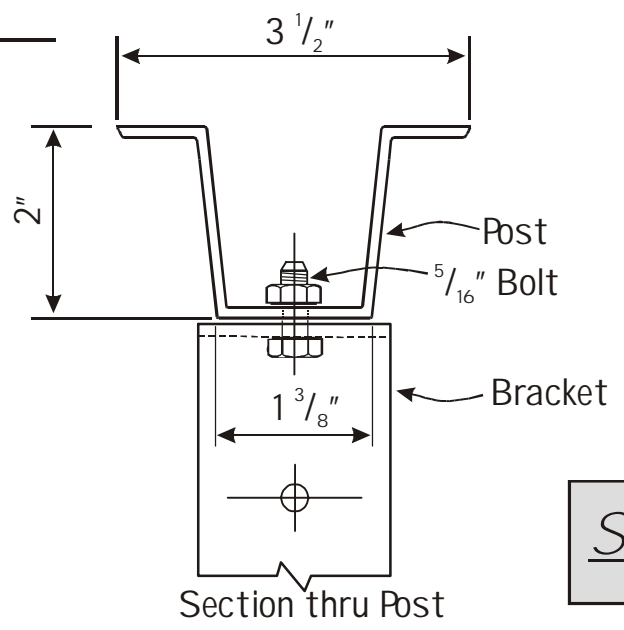
NOTE
 Plywood base is to be cut to fit size of mailbox and centered on bracket

2. The ground is frozen, a salvage steel sign post per the attached drawing may be installed in lieu of the standard wood post as shown on Standard Plan R-74 series.
